Architectural Conservation and Historic Preservation
Prof. Sanghamitra Basu
Department of Architecture and Regional Planning
Indian Institute of Technology, Kharagpur

Lecture – 24
Causes of Decay in Cultural Property (Contd.)

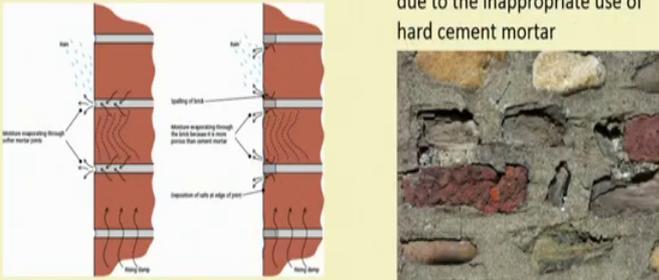
Spalling of stone in a historic wall due to the inappropriate use of hard cement mortar

One of the very prevalent cause of historic structure is that the use of wrong mortar. In most of the earlier structure the lime mortar has been used and when in such cases cement mortar is applied what happens cement is much stronger. So, as you can see that when the cement is much stronger it causes the spoiling of stone in a historic wall. So, the mortar has remained safe, but it has really caused the problem to that.

Why it happened? So, you can see in this diagram that if there is a cement mortar and brick or stone which are the porous building materials the water would like to come out. We have discuss about the penetration of water, we would like to come out it may be due to the rain or the rising dampness. They would like to come out through the pore and generally what happens is that they would like to come out through the joints and if the lime mortar is used it is possible.

In case of the cement mortar it is much stronger and much more impervious. So, what happens is that they cannot come out through that. So, they try to come out through the evaporating and other thing, they would like to come out through the bricks and in that process they it causes the spoiling of the bricks and the you can see that the mortar has remained safe.

So, it is absolutely very important to use a mortar which is less of lesser strength than actually the building fabric and this is a very common damage which happens because of the using a modern cement mortar to repoint the old walls.

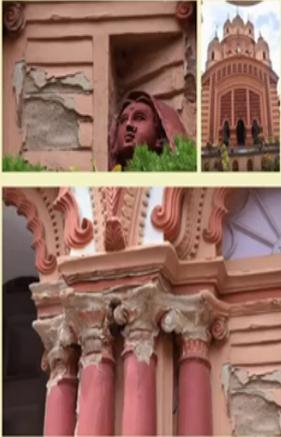
Terracotta temple Alangiri, Pingla, East Medinipur

Modern emulsion paint and as you can see that this is falling off. So, a beautiful which may look for a short time it may look good, colorful, well preserved, but in a long run it will cause further damage it. You can see that it is falling off and it is also bringing out the original material. So, these type of repair methods are very dangerous for the historic fabrics.

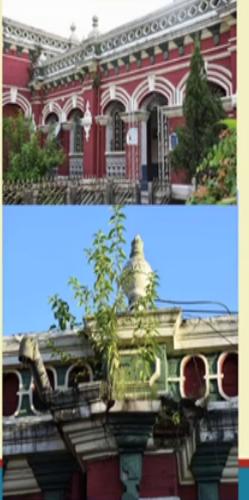
*Jenkins School
Cooch Behar*

The neglect is another things, this is a beautiful school building in Coach Bihar in northern Bengal Jenkins school um. As you can see that is quite well preserve, it is used.

This is the front portion and they paint it regularly, but due to the neglect as you can see that in this portion there is not proper, it is a flat roof structure though there is not proper drainage is happening on the flat roof. And actually eventually there are saplings which are growing up and this is causing further damage to this structure and it is also in a very precarious state.

So, this type of neglect what happened there is a very simple reason which are really easy to take care of like blocked rainwater goods so, broken grills and plants growing in the gutters and walls. They encourage the moisture to penetrate the fabric or also sometimes the slipped roofing tiles which can cause which is very easy to repair. But, due to neglect probably the rusting of the metal windows, expose woodwork, algae and the fungal growths which you have all discussed of the natural causes of decay and excessive moisture inside the building etcetera, etcetera. These are all due to the neglect which can be taken care of as I told very easily.

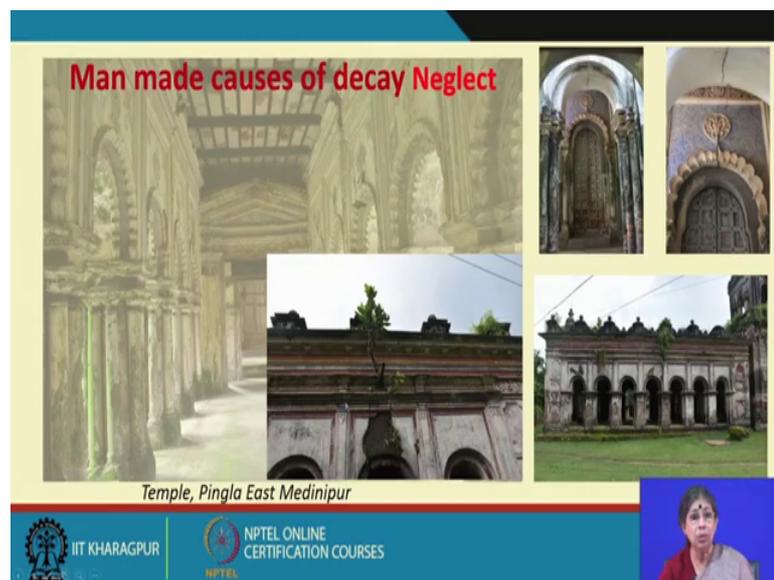
This is another beautiful structure, these are old in immutable structures in our smaller towns or villages and other things this is again a private property. The beautiful structures you can see that multiple art and it is a influence of the across cultural influence.

Again it is flat roof structure and so, that you can see that there are planned grows of vegetable growth on the roof. And as a result what is happening is that some of the

portions are very well preserved like the decorations and others as you can see a clear picture. But what has happened because there is a not proper care has been taken to remove the vegetative growth and there is a huge sort of a vegetative growth on the roof the and there is a water logging. So, it is actually causing a crack to the structure and that is a very severe cracking so, I can see that.

And this is just a minor problem which could have been tackled very easily, just a regular maintenance policy is more than enough to take care of that. And these man made causes of decay or the neglect is actually a very very prevalent cause of damage to the many many our historic structure.

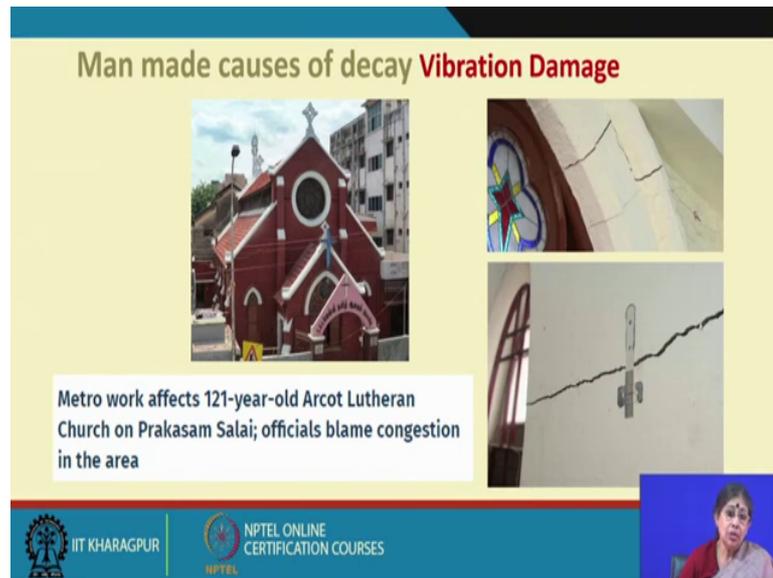
You know that the metro digging for the metro corridors are very important and it is happening in most of our city. This is you see the metro railway work in Chennai; it has affected a 121 year old Lutheran church.

And you can see how the cracks have been developed and the experts have been called, they are trying to sort of monitor the cracks. and these are the problems which probably it if people concerned about that then precaution can be taken beforehand or again I say in extreme cases even the re aligning the corridors the things is important.

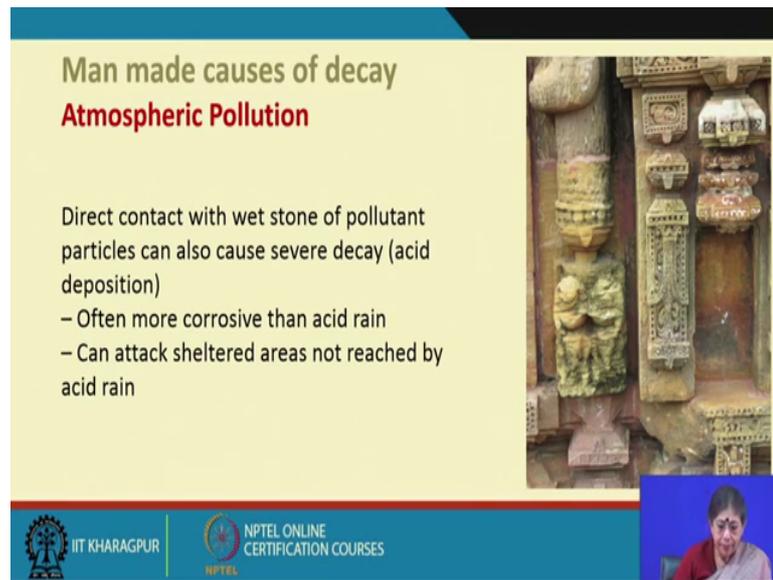
Direct contact with wet stone of pollutant particles can also cause severe decay (acid deposition)

- Often more corrosive than acid rain
- Can attack sheltered areas not reached by acid rain

So, direct contact with the wet stone to a pollutant particle can cause severe decay or the acid deposition often more corrosive than the acid rain. And sometimes what happens is that if 2 or 3 types of stones are used and these are differently affected by the rain and they can also have a different impact on the subsequent layers of stone. So, one has to be very rare and see or investigate very clearly what is the material and what type of pollutant is happening.

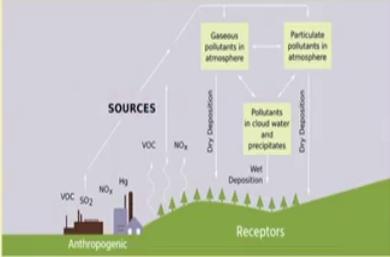
When atmospheric pollutants like oxides of nitrogen and sulphur react with rainwater and come down with the rain, then this results in **Acid Rain**.

The formation of calcium sulphate results in the corrosion of this beautiful monument.
$$\text{CaCO}_3 + \text{H}_2\text{SO}_4 \rightarrow \text{CaSO}_4 + \text{H}_2\text{O} + \text{CO}_2$$

This is a sort of picture that how the acid rain is forming, the gaseous pollution pollutant in the air and dry deposited particles and these pollutants in cloud and other precipitates. And they sort of then they go from the various industry, the sulfuric acid and this with the rain they come down and deposit on the surface and they cause a corrosion of this beautiful monument.

So, one must understand that what is the reason, what is the process and what type of mitigation measures; as I said the height of the chimney or totally removing those type of pollutant industry from the close vicinity at certain distance where it cannot cause this type of problem.

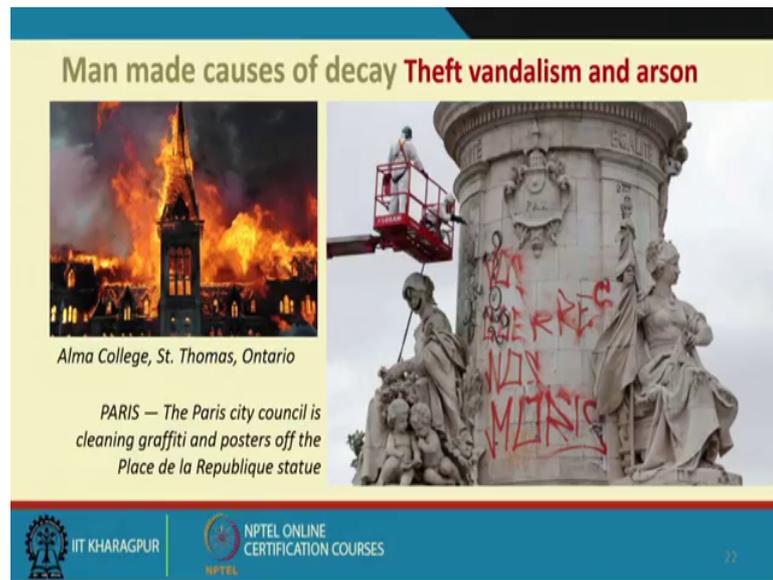
Another man made cause of decay is the theft vandalism and arson, you can see that this is an Ontario a church. There was a discussion happening that there was a decision to destroy the church, demolish the church. Then the local community holders were meeting the government to stop it and that day they were meeting that and that night it was put on fire with an arson. And it happens everywhere that in terms to give place to the new development, a lot of heritage structures are being demolished rather than looking into that what can be the other alternative solution.

And as you see in Paris that this is a very common site in the heritage places or heritage structure people feel like writing use of gravity and other; this it is a very irresponsible behavior not showing proper respect to the historical and heritage structure.

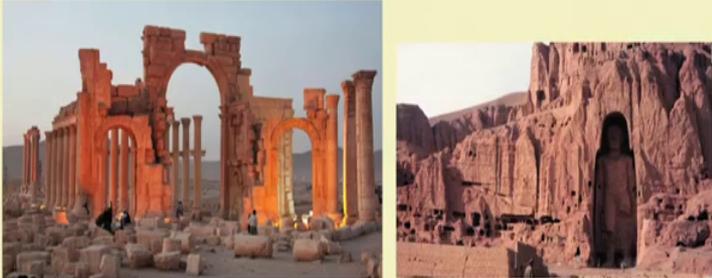
The ancient city of Palmyra
located in war-torn Syria, flourished as a Roman trading outpost around A.D. 200. Destroyed by ISIS militants

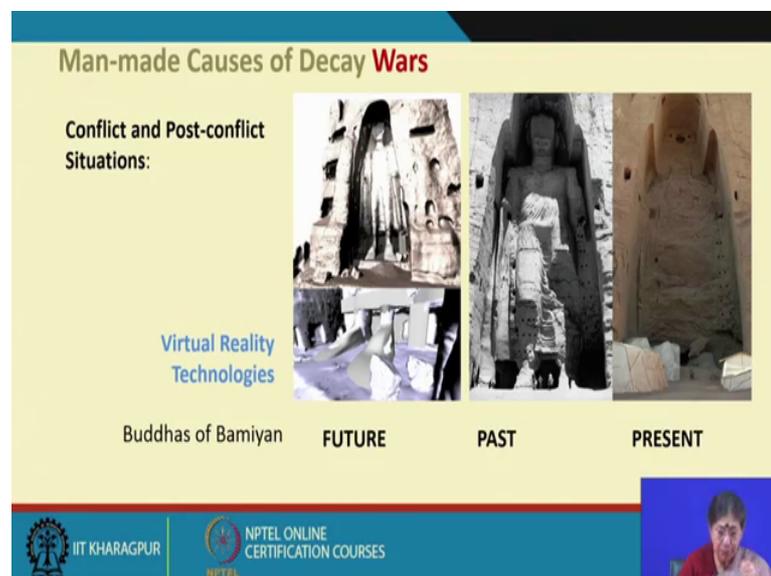
And now what is happening is the there is a different technology is happening. So, virtual reality technologies are helping a lot of work going on to actually reconstruct and help in reconstructing the Bamiyan Buddha that to what degree it is happening. So, you are using the new technology to in the reconstruction process.

So, one of the option people are talking about is the restoration through anastylosis because for the smaller Buddha many of the debris are still there on the site, but as we see that we have come a long way.

. So, should it go into anastomosis, should be sort of put together or is there any other way of reinterpretation or the discovering this Bamiyan Buddha are bringing back bringing back not physically, but concept wise what are the other ways.

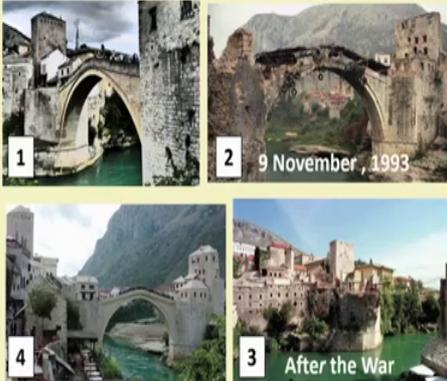
Reconstruction of Mostar Bridge
Mostar, Bosnia and Herzegovina

- The 16th-century Mostar bridge blown up during the bitter fighting in the Bosnian war in 1993.
- **reconstruction**
symbolic healing of divisions between communities
- The single-arch masonry bridge and related structures were **rebuilt** using the original methods and materials

Another example or I must I mean I have talked about a lot of this is the monster bridge it will happen in it was a 1670 bridge and due to a bit of fighting, it was destroyed. As you can see that this was the old bridge and this is in November 1993 this was damaged due to the war it was destroyed and this is after the war there was nothing there.
