Fire Protection, Services and Maintenance Management of Building
Prof. B. Bhattacharjee
Department of Civil Engineering
Indian Institute of Technology, Delhi

Lecture – 46
Case studies of visual survey

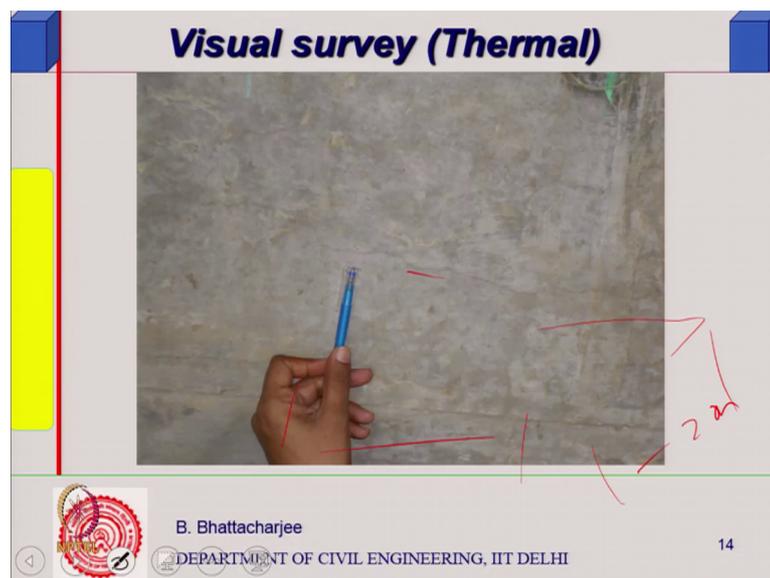
(Refer Slide Time: 00:52)

So, having looked at some of those intrinsic crack related to shrinkage let us look at some thermal cracks. Now, one set you know this is again a massive concrete right, now you can you can see the cracks possibly something like this you know you can see this cracks, some cracks here this is the is not easy the pen shows those, the pen here now this cracks is of a bridge pier, bridge pier is actually approach to the bridge right.

Now, the dimensions were too large, something like you know I exactly do not remember, but the width is 2 meter pier and the span you know length is because of 6 lanes. So, I think it was a continuous; it was continuous, but this width was not less than 2 meter it was width was more than that so, depth is 2 metre height is; obviously, high.

Now, is this such kind of a thick concrete volume to surface area ratio is very large is almost like mass concrete, the grade of concrete was I think 35 or 40 or something of that kind relatively high grade used a 53 grade of cement right use 53 grade of cement which actually produces more heat of hydration early and concrete grade was quite high so, cement content was also very high.

So, this developed this kind of thermal so, thermal cracks do come in large structures, you know where you have a like a thick craft thin sections usually you should be one should be careful about shrinkage, thick sections very thick section thermal cracks are the once which are likely to come. So, this is what the case was this is the same place same bridge it is showing further cracks somewhere you know somewhere these are the piers, these are the you know these are the these are beam which is supported on piers.

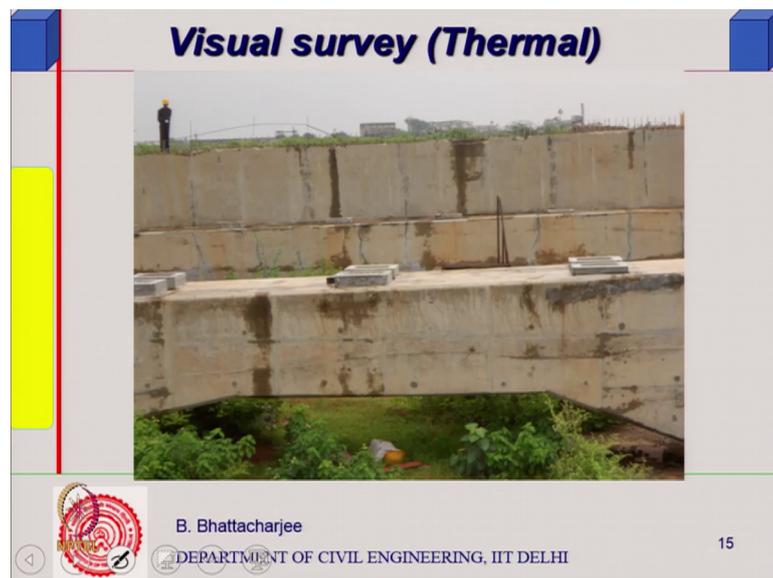
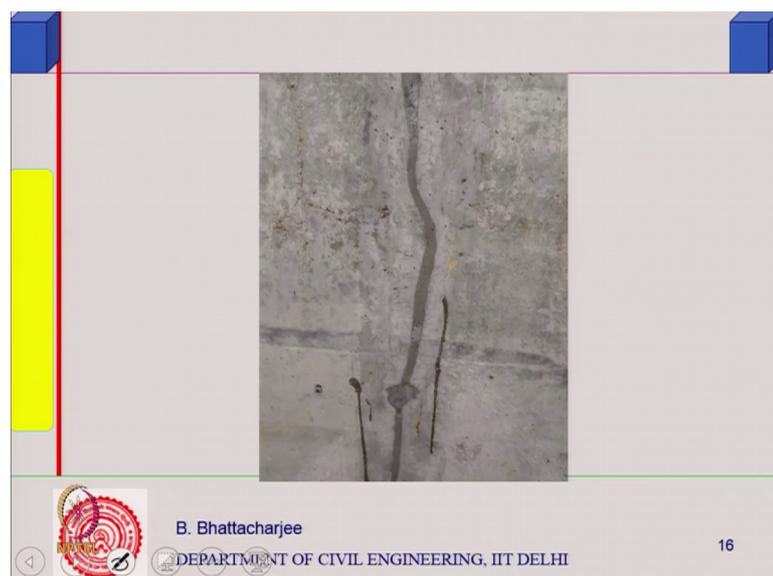
(Refer Slide Time: 02:43)

So, is the approach this is the approach basically you know there is a approach and then here the gardens are supposed to come but, the cracks the cracks thermal cracks of this form. But one of that the filled it in with some sort of.

Yeah some sort of polymer modified system, but the main cause was the high relatively higher grade concrete, relatively higher grade concrete with a high you know early strength cement 53 grade which would not have been the case and heat of hydration resulted in such crack formations.

So, one has to be careful, you know the heat of hydrations the of cement should be low, if you request friend and then this you know I mean the section everything should be taken into account heat of hydration, the rate of strength development required and the structural requirement. So, I think here structural requirements were satisfied with the thickness, when it came to strength development I am not sure because this was lying you know lying unloaded for so long time; that means, the time was not a constraint here.

So, strength development was not a constraint, but then peoples you know I was told the structural designer insisted on 53 grade of cement and the high strength. So, actually that cause it is sort of crack, although these are intensive crack, but they have their long term effect anyway.

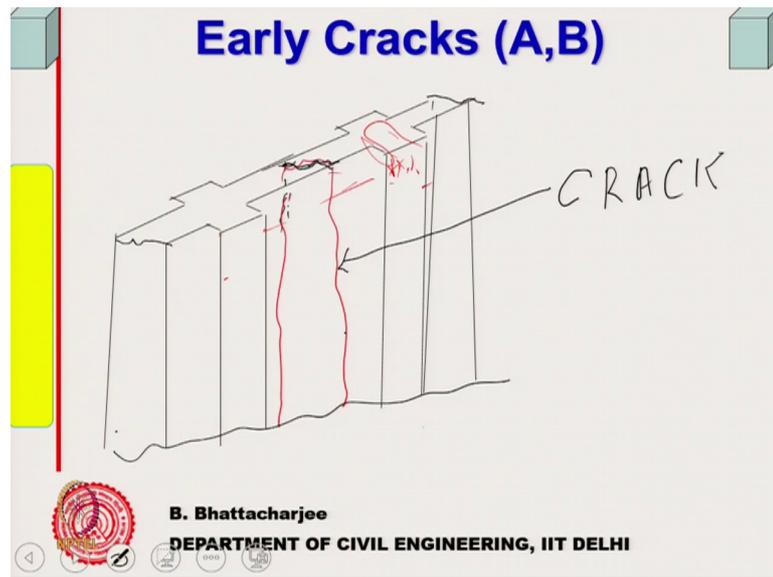
(Refer Slide Time: 04:07)

So, this was the cracks so, case A and B early cracks there was something of this kind, these are the vertical cracks you have seen between the kind of you know plasters I mean there are higher thickness case A and B as I mentioning the shrinkage cracks earlier in the previous lecture. So, the between you know there are kind of bar process you can say right extended section here.

So, exactly near the centre of this one, because this is restrained here. This is shrinking, this is thicker do not shrink you know not allowing it and the cracks were almost equally spaced on in each of these between these two you know between the two bar process sort of thing.

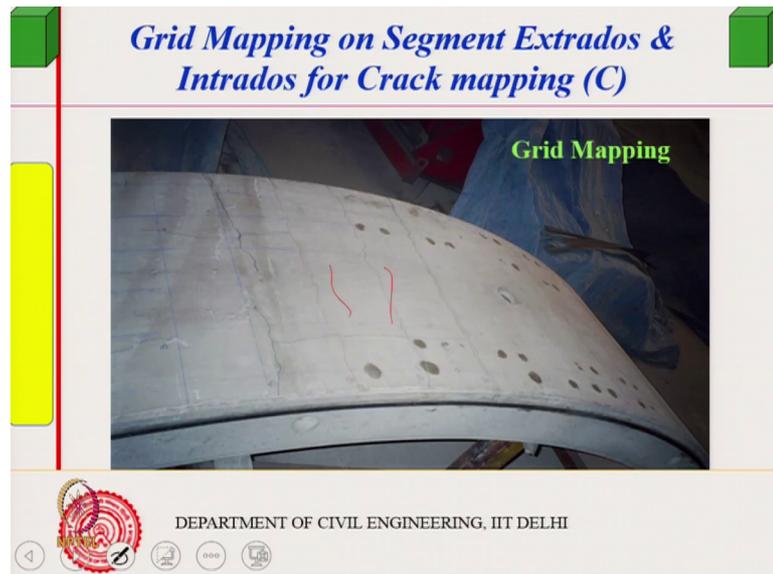
(Refer Slide Time: 05:01)

So, this was the case A and B both A and B show this, C should this is a I was talking about the segment you know 280 mm thickness you can see the cracks the red, blue etcetera. Because it classified them, you know you can see the cracks like this there are lot of cracks on this convex side there are nothing on the concave side so, convex side there are plenty of cracks.

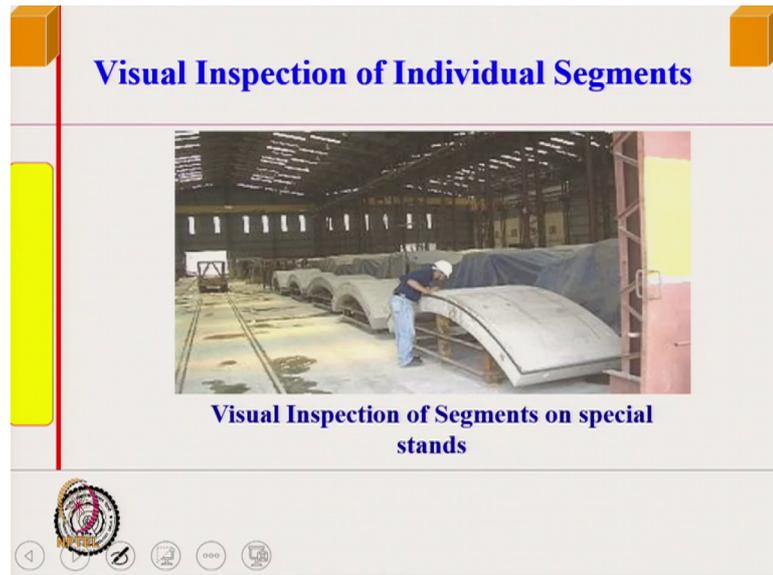
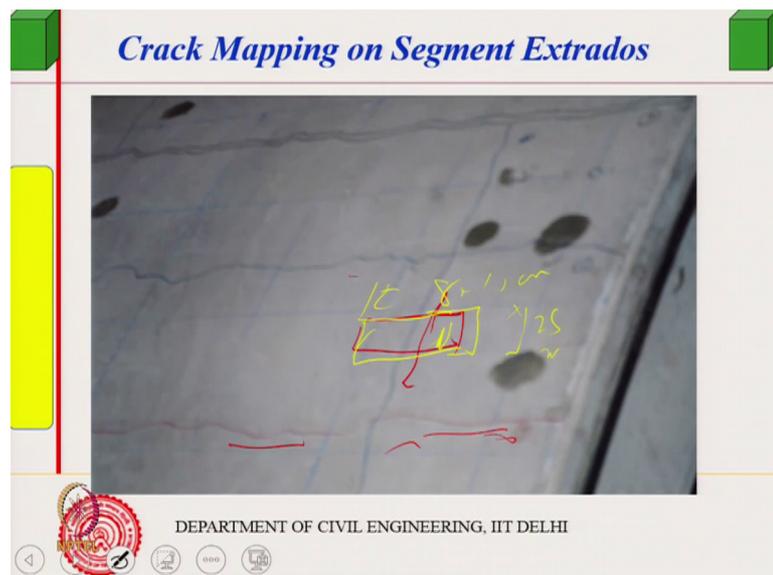
(Refer Slide Time: 18:00)

And this is how somebody is doing it, visual inspection has been done is being done and this shows the colour coding you can see that these are all blue, this is blue this is red,

single line red, blue colour, blue, red some more big green double red perhaps were not there. At all you know you can see that there is a red fine red line going on above my red, my green line these are all blue mark you can see that so, all cracks were actually colour coded and marked right.

So, based on this what was done was used a colour coding, used colour coding for the cracks all the cracks are mm all over all the segments this is an example how one does visual survey thoroughly right, there are some more examples I might look into. So, green, if the colour is green the crack is marked with green marker pen you know first all the elements well laid down with their convex side on the surface. The doubtful cracks one by one, batch by batch something like maybe 16, 8 or 16 you take today look at them mark them and then identify etcetera. Green colour means width less than 0.08 mm, this you know is as I said you can measure them I will next time I think I will bring that and I will show you there is the small scale, but there are better methods of then measurements are also crack with measurement.

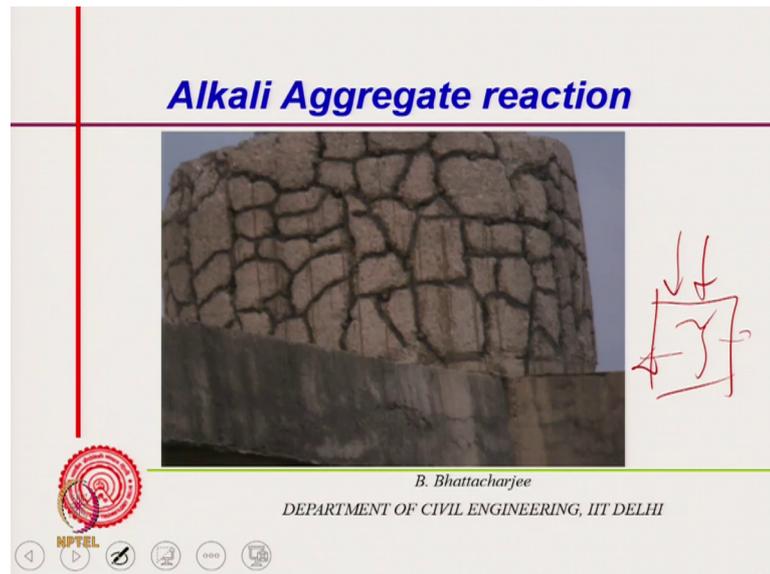
(Refer Slide Time: 24:01)

Now, yeah this one is a real case of an alkali aggregate reaction in Indian scenario northeast, you know after sometime say basically support for tower support for tower right. So, they use aggregates which you are not tested really because the finished off their earlier aggregates and it give up cracks of this kind. So, they are not very sure why it is happened, well us you know somebody can be jolly well diagnostic as possible because, the load that can, but load internal pressure was you know there will be no internal pressure, If I put some load on to a pedestal you know it would bulge along this direction.

So, I will have cracks, but why horizontal cracks so, this was actually you know, you have to use your common sense of load flow as well, visualised how the load flow is taking place this was an cracks which came after about 10 years in service.

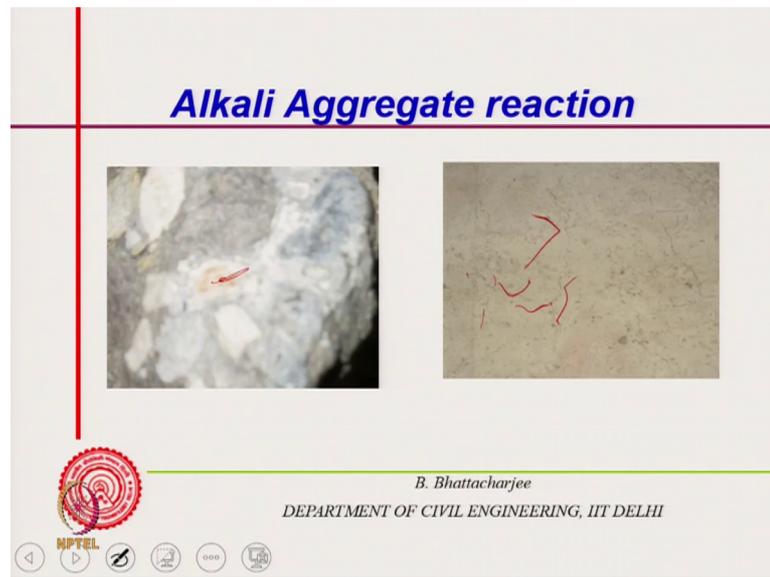
(Refer Slide Time: 25:10)

So, because they use an aggregate and this is an example of alkali aggregate reaction now how do I so, I am so, confirm. Because we when we take out the aggregate from the same one I find the aggregate and then the white alkali silica gels were silica gels were very much there right.

And many other parts of the structures whether cracks are not so, much one can see cracks like this, one can see map cracking all over the place you know all over the place they cracks. So, this was the case of an alkali because of some of the piers, it is piers of tower supporting structures wells well this is well that was the pedestal.

So, they use aggregates which you are not really tested over time and did not do test for alkali aggregate reaction, you will see white patches like this. And there are other additional test, to take the samples chemical test you can do or petrographic analysis you can do to find out on those aggregates what are the minerals presents.

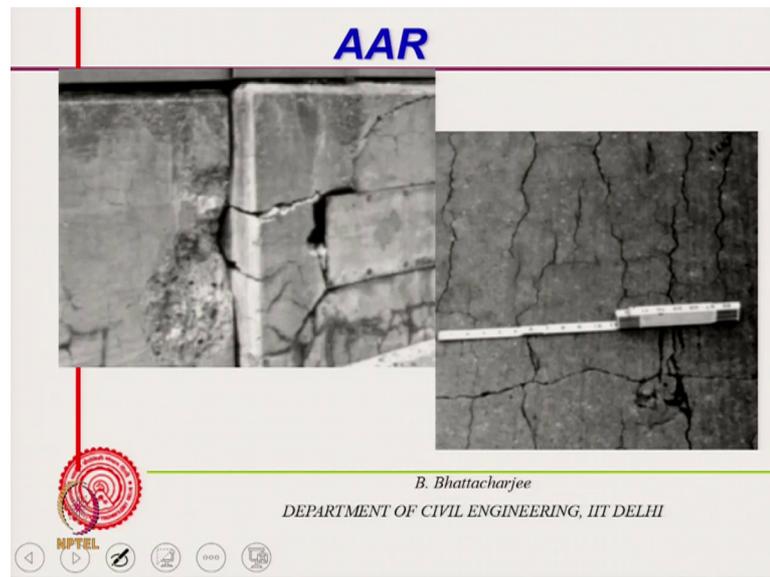
(Refer Slide Time: 26:07)

So, alkali aggregate reactions can be identify in this way, these are some examples of alkali aggregate reaction a broad from literature only. So, visual observation is important if you see this you can actually find out and this is what alkali aggregate reactions would look like some of them right.

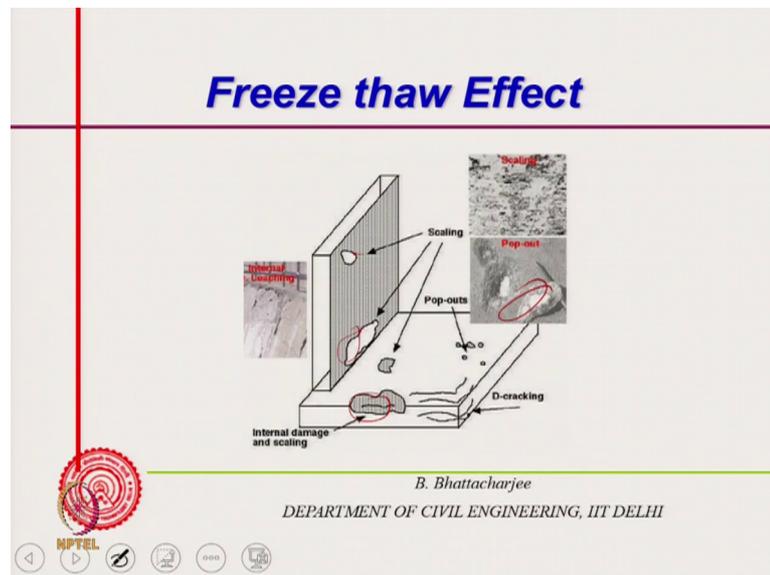
(Refer Slide Time: 26:27)

Now, freeze thaw effect is not very common in India, but this is how one it might looked freeze thaw effect might look something like this, some pop out here scaling somewhere you know. So, freeze thaw effect is because of the ice occupies more volume than water.

So, in a saturated concrete if it freezes exerts pressure, ice exerts pressure internally and this can results in sort of you know internal pressure generation and over the years after many cycles I do not think I will go into the concrete science of hit at the moment.

But freeze thaw effect can also be identified kind of popping that you see pop out concrete, scale you know cracks etcetera from the surface deterioration you can actually find out.

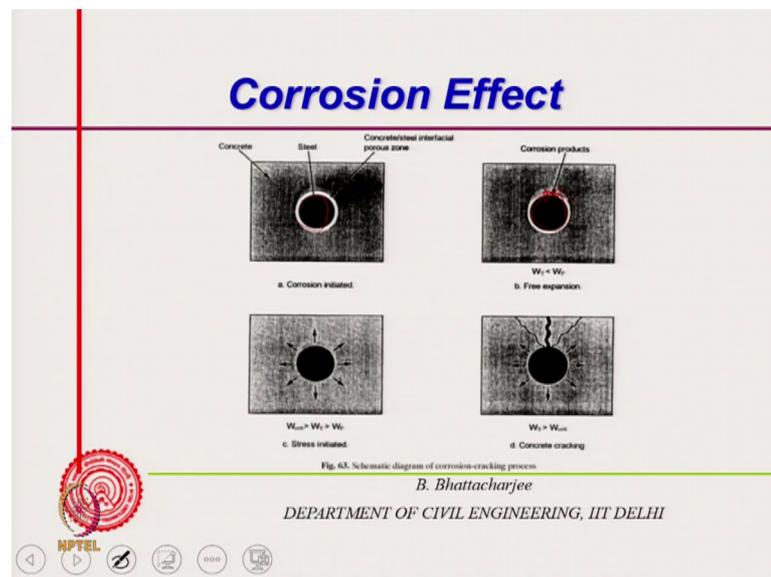
(Refer Slide Time: 27:25)

So, similarly corrosion typically corrosion would look like this river corrosion would look like this I showed one example. Initially it is like this, then rust would rust product will occupy the surrounding exerts pressure and finally, the crack comes like this.

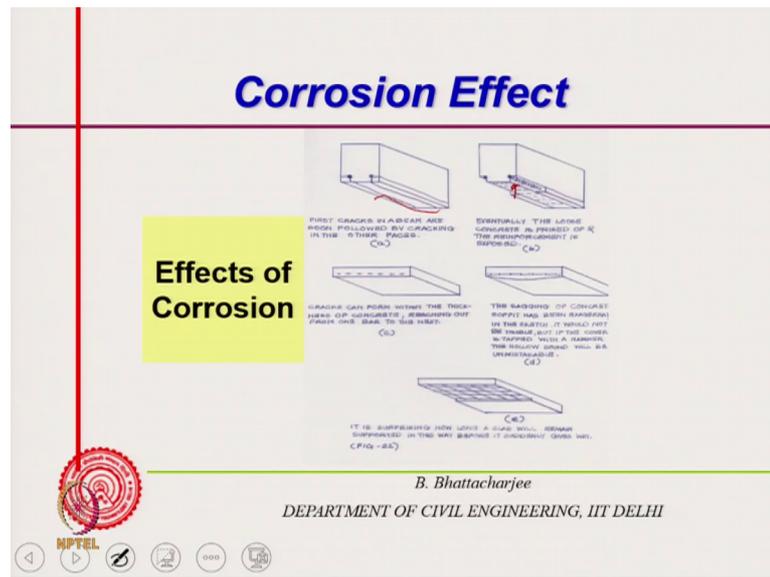
(Refer Slide Time: 27:43)

And result should be something like this beam you will see cracks parallel to the line bar like this sometime or later it will simply follow up in slabs you may not see the beginning, but see a sagging and then it will come out like this.
