**Advances in UHV Transmission and Distribution**  
**Prof. B Subba Reddy**  
**Department of High Voltage Engg (Electrical Engineering)**  
**Indian Institute of Science, Bangalore**

**Lecture – 05**  
**Non ceramic insulators performance-service experience**

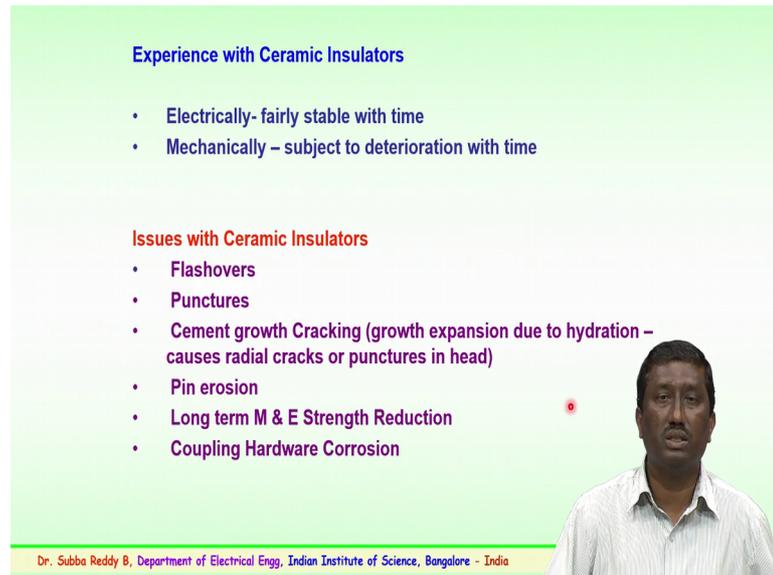
(Refer Slide Time: 00:14)

**Experience with Ceramic Insulators**

- Electrically- fairly stable with time
- Mechanically – subject to deterioration with time

**Issues with Ceramic Insulators**

- Flashovers
- Punctures
- Cement growth Cracking (growth expansion due to hydration – causes radial cracks or punctures in head)
- Pin erosion
- Long term M & E Strength Reduction
- Coupling Hardware Corrosion

So these are some of the things mechanically could subject or deterioration with the time that is a long period of time. So, what are the issues which have been with ceramic insulators or (Refer Time: 00:25) insulators are the flashovers. This again flashovers depend upon the pollution areas or a contaminated areas, where the insulator over a period of time contaminates get collected on the surface and in dry season the problem of flashover never happens.

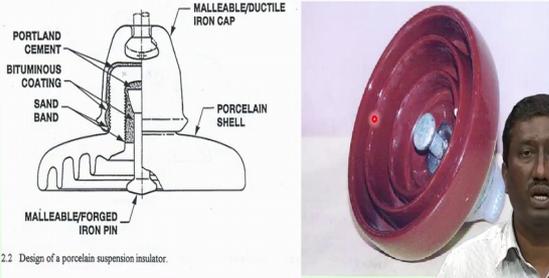
2.2 Design of a porcelain suspension insulator.

**Ceramic / Porcelain Insulators**

- Used since 1830s (for telegraph lines)
- Used at all voltages for line insulation
- Provides great flexibility (cap and pin)
- Strong in compression
- Available in various shapes (simple-complicated)
- High degree of standardization

So, this junction where the Portland cement is used over a period of time could lead to the growth and expansion and sometimes a radial crack or a puncture in the head of the insulator or the surface top surface of the insulator is being noticed. Then pin erosion again depending upon the climate or environmental factors over a period of time the erosion on the pin has been noticed this could also lead to the failure of insulators or issue with the ceramic insulators.

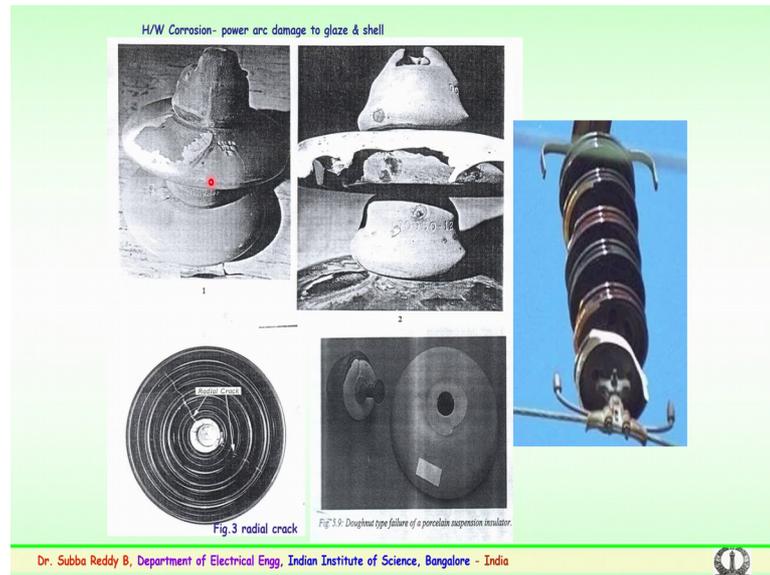
(Refer Slide Time: 03:07)

So, these are some of the failures which have been observed over a period of time in the field. You can see the glazing on the insulators over a period of time is completely not available which will lead to the surface flashover and the insulator failure will happen. So, this again are the punctures of the insulator or the breakage of the shed because of the long period of time which has served.

Similarly, because of the Portland cement the cement growth near the pin junction has led to radial cracks or this may be because of the compressive loads which the insulator has seen. This type of failure this particular figure shows you the cap and pin getting detached which is known as a doughnut type of failure, where the material detaches itself from the ceramic unit over a period of time. And this is because of the lightning over voltages the insulator string has seen in the field where the insulator shed could be shattered because of the over voltages of the very sharp price in voltages.

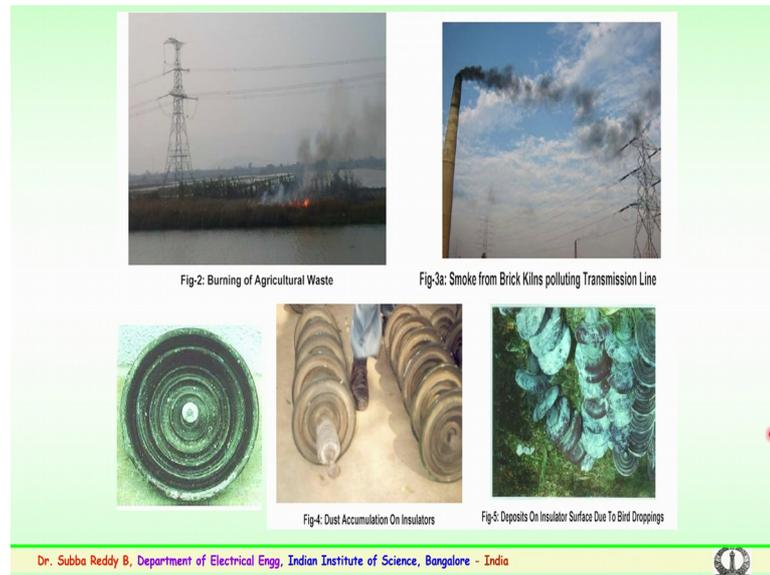
(Refer Slide Time: 04:23)

So whatever we have seen are the natural things which have happened. These shows again the artificial problems or the manmade problems was the insulator strings which could a fail much before their life that is reason may be because of the burning of the agriculture waste in a particular areas or because of the like a sugarcane or many other agriculture after the crop is completed, they try to burn the remains of things which are this cause lot of a the dust lot of contaminants which go and settle on the insulator surface over a period of time, and they become hardened on the surface and during the monsoon conditions the surface becomes wet and likely to flashover.

So, the second being again some of the brick kilns or a very high polluting areas industrial areas, where the atmosphere smoke coming into the atmosphere could go and again settle on the surface of the insulators which are nearby, to these factories or nearby to these industries where the transmission lines which are of extra high voltage and ultra high voltage gets polluted or surface gets accumulated with the pollutants could lead to after becoming wet could lead to flashover.

So these are again the various a types of accumulation of does on the surface of insulators again this is the bird droppings over a period of time many times you must have noticed that on the transmission tower several huge birds make their nest and try to see the droppings of that will again be settled and get polluted the insulator gets polluted over a period of time. And this will lose the property the insulator will lose the

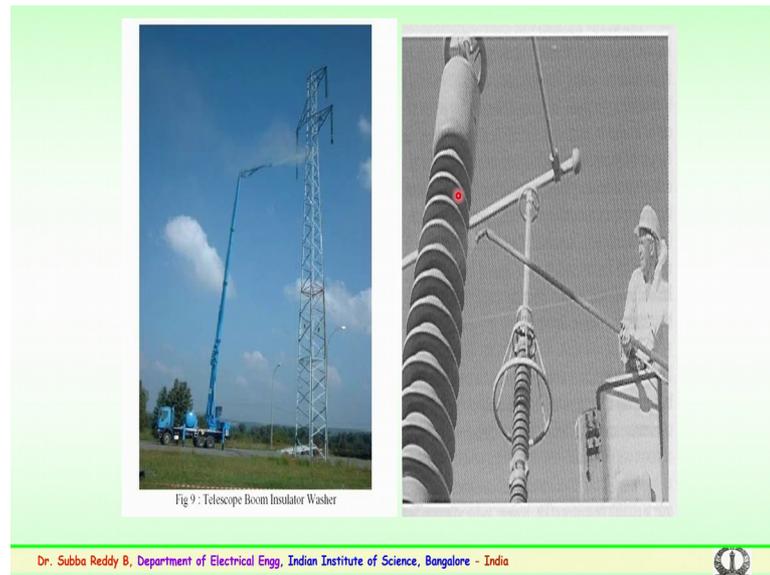
(Refer Slide Time: 06:53)

So, some remedial measures for the insulators so much before the monsoon start. So, remedial measures have been done by the electricity authorities or the utilities to see that the flashovers do not happen. So, one among the thing is what you see is the telescope type of the jet, which is being used to wash or clean the insulators a mounted on a truck. So, this telescopic type of arrangement with water jet at a particular conductive level dry to clear the insulators and see that the contaminants which are deposited over a period of time is done, where in particularly do in the pre monsoon conditions the flashover of insulator is not happening.

Again this is a live line arrangement which has been will be done; technician or a person who does the operation is on a particular insulated arrangement. Where he uses the water jet to clean the post insulator particularly in the substation or as bushings of the (Refer Time: 08:11) and several of these contaminants which spread over a time period have to be properly addressed that is a clean. So, that during monsoon condition the surface of the insulation does not become wet and starts conducting to arrange the conduction. So,

proper cleaning of these contaminants or pollutants is essential. So, one is a live line washing which is being shown here in this figure, the live line washing is also very important because you cannot interrupt the supply over a period of time.

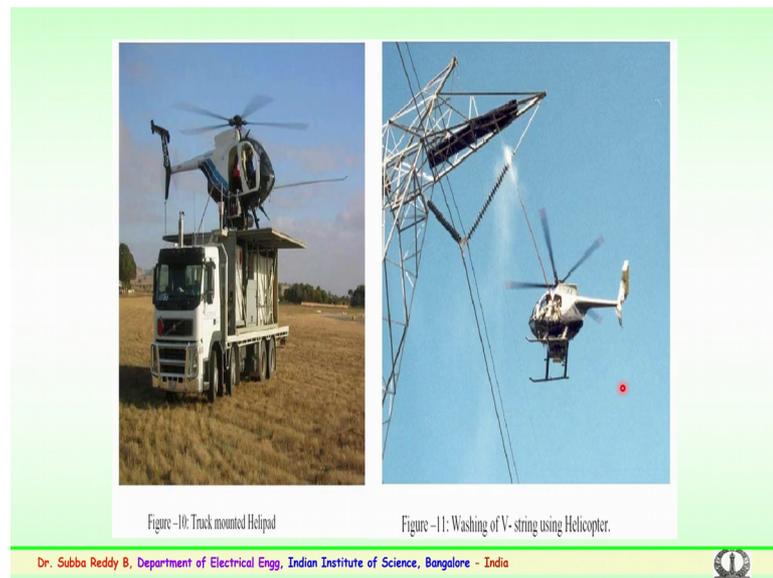
(Refer Slide Time: 08:55)

And there are other methods which are being employed, where areas like high altitude mountainous areas or the areas where the vehicle that is truck with jet could not approach in such cases, helicopter mounted nozzle sets are being employed. And here the help of helicopter mounted jets the water jets is cleaning of insulators is being done. Even though, it is of higher economy involved in these aspects, the cleaning or the washing of insulators very important. In areas in the forest where the normal truck could not be will not be able to go there. So, such cases helicopter mounted nozzles are being used in high altitude and the some forest areas.

Apart from this they are also try the trimming of the branches how to be carried out much before the when or much before the monsoon happens where this trimming of branches it is also very important. So, these are some of the measures which are being employed regularly by the utilities.

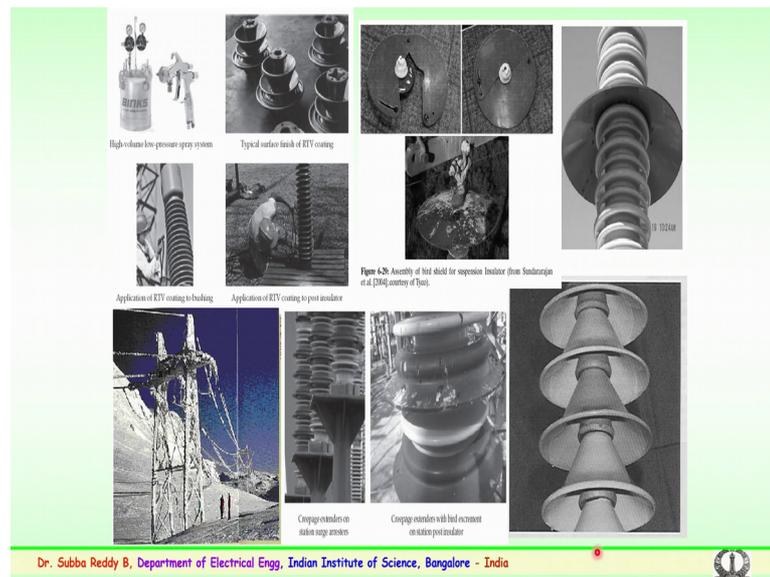
(Refer Slide Time: 10:07)

To see contain the flashover of insulators some again apart from this you see various types of remedies I have been employed to improve the performance of the insulator. This is one such small arrangement on the surface of the insulator to increase the creep age of that again insulating material, which is known as creep age extender is employed to see that the bird droppings or this particular insulator improves for a certain period of time.

So, this also has been tried out again this is for a substation post insulator which is known as a creep age extender to tries to see the flashover does not happen even the surface is become contaminated this will help partially to see the flashover do not happen. And some designs I have also been tried out which is a without the petticoats where contaminates does not settle over a period of time. So, such designs are also being tried for the better performance in the field. And this figure shows the transmission lines particularly in high altitude and very cold areas that is the high altitude where the temperature is very low and freezes.

So you can see the insulator strings are completely covered with ice and the conductors completely covered with the ice. So, this will lead need lot of revenue particularly for the utilities to maintain the clean of these things else the flashover will definitely happen of the conduction of the surface which is in continuously ice formation which is happening in cold countries. So, lots of measures have to be taken by the utility or a transmission

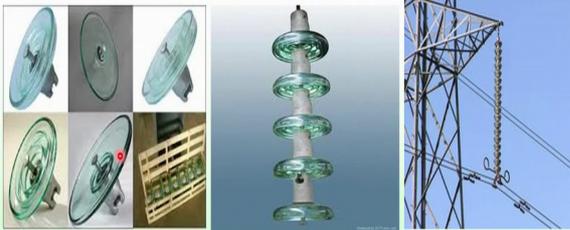
(Refer Slide Time: 12:05)

**2. Glass Suspension Insulators**

- Good contamination performance due to self cleaning properties
- Good for remote areas with no gun shooting & helicopter patrols
- Outer glass surface under higher tension than inside glass
- Damage to outer surface causes violent shattering of shell
- Spontaneous failures
- Attractive to shoot because the shell “explodes when hit
- Shattered glass is a safety hazard
- Not popular in US, used in Europe, Canada & Brazil

So, that was about the ceramic or a porcelain insulator which we have seen quick look at the glass suspension insulators. Again glass insulators are of very old like almost similar to the ceramic or porcelain. They have good contamination performance due to self-cleaning properties. And they are good for remote areas particularly with no gun shooting or helicopter patrols where some people shoot the glass insulator for fun where the insulation sheds shattered and the insulation level decreases.

So again the outer glass the glass which is being used is a under high tension compared to the inner side sometimes the failures or a shattering of this happen on the outer surface. So, with a violent shattering of the shell sometimes a spontaneous failure also I have happened in the field. As mentioned attractive shoot because the shell explodes; so some people take it as a fun and try to bring down the insulator or shoot the insulator. Later this again the shattered glass is a safety hazard as per again disposing of these shattered glasses is environmental issue.

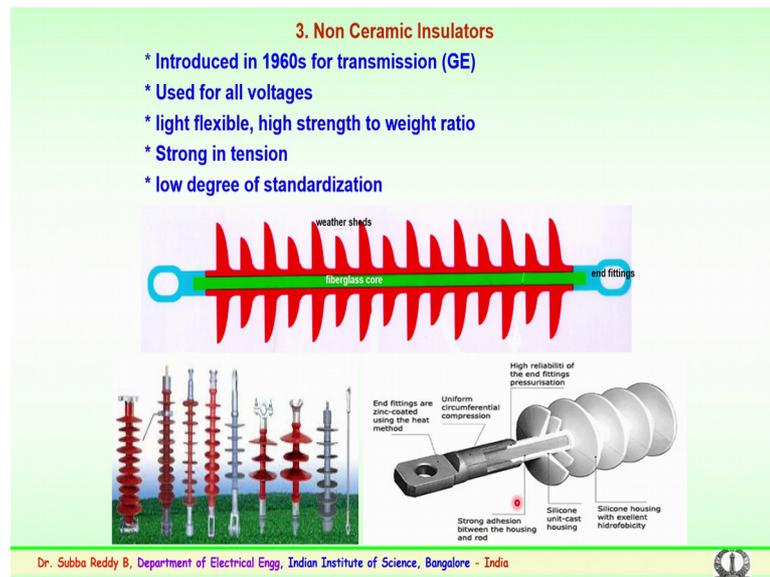
(Refer Slide Time: 13:47)

So these non ceramic insulators are again recent origin, and advanced technology particularly in the insulator field. These where introduced somewhere in 1960s in initially for transmission particularly by the general electric presently being used for all voltages from a very low voltage to up to ultra high voltage levels. And these are light flexible and I have a high strength to weight ratio that is a very important and strong intension and low degree of standardization. So, this is how typical polymer insulator looks.

Polymer insulator as I mentioned will have a fiber glass a rod which is shown here. In the green color this fiber glass rod is a fixed with the metals end fittings. This metal end fitting one of the fitting is connected to the tower and other is connected to the conductors with suitable hardware. So, the fiber glass rod is connected with the metal end fittings, later on with the help of the liquid injection molding the silicone rubber or polymer sheds or a weathering sheds what we call are being molded on this fiber glass

rod. Again the length the type of metal fittings depends on the voltage level which the insulator has being used.

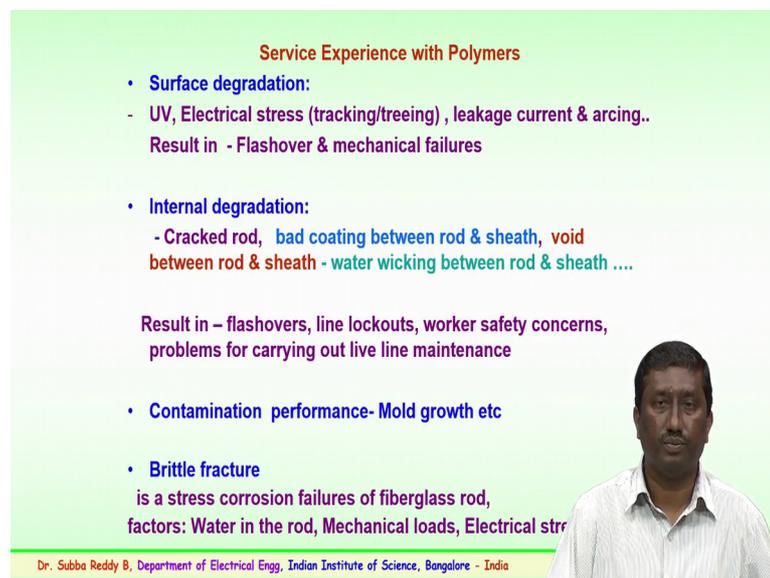
(Refer Slide Time: 16:57)

**Service Experience with Polymers**

- **Surface degradation:**
  - UV, Electrical stress (tracking/treeing) , leakage current & arcing..
  - Result in - Flashover & mechanical failures
- **Internal degradation:**
  - Cracked rod, bad coating between rod & sheath, void between rod & sheath - water wicking between rod & sheath ....
  - Result in – flashovers, line lockouts, worker safety concerns, problems for carrying out live line maintenance
- **Contamination performance- Mold growth etc**
- **Brittle fracture**
  - is a stress corrosion failures of fiberglass rod,
  - factors: Water in the rod, Mechanical loads, Electrical str

So surface degradation is the important aspect; the surface degradation may cause because of the ultra violet rays this is because of the sun or from the corona of the hardware which we mentioned. Electrical stress continuous electrical stress on the insulator over a period of time could track or treeing track or treeing is again the slow failure of the insulator surface where a tracking could occur and the insulator could see the leakage current flows and degradation of the material could happen.

So, this tracking or treeing of the surface could happen over a period of time, because of the electrical stress where in the leakage current and small arcing which are known as a partial arcing or the scintillations could happen which could result in the flashover and sometimes the mechanical failures because of the surface degradation. Then internal degradation this internal degradation we know that internally fiber glass or rod is being used where some times because of the hydraulic pressure which is being use to crimp the end fittings the metal fittings to the rod could lead to a cracked rod or sometimes bad coating between the rod and the sheath there is a coating which is applied this could lead to very small voids between the rod and sheath, where the reports have a seen or the service experiences seen that the water could entire with the very small blow holes or a hole and this could in case of the water entering surface of the rod.

And the where the nitro nitric acid is form formation is as seen and because of this nitric acid the rod and the sheath failures are happen where the brittle fracture of the insulating rod could lead over period of time. So, these have also been seen in the field. So, the result is the flashovers sometimes could be temporary or continuous flashovers could happen line lockouts or blackouts or the line may give away. So, workers safety concerns. So, very important in case of failures, it should not lead to the safety concerns particularly for people who are caring out the live line maintenance.

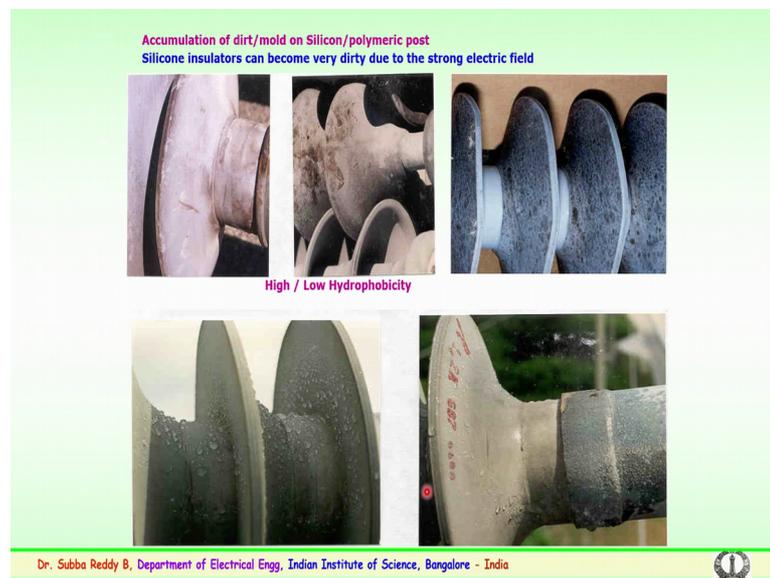
(Refer Slide Time: 21:40)

Some of the early failures of the polymer insulators which have happened in the fields this may be because of the accumulation of dust mold on the polymer or silicone rubber post. So, silicon rubbers cold become very dirty due to the strong electric fields we can see a over a period of time the insulators becoming dirty and the surface getting rough and where the water droplet us start collecting and the failure could happen.

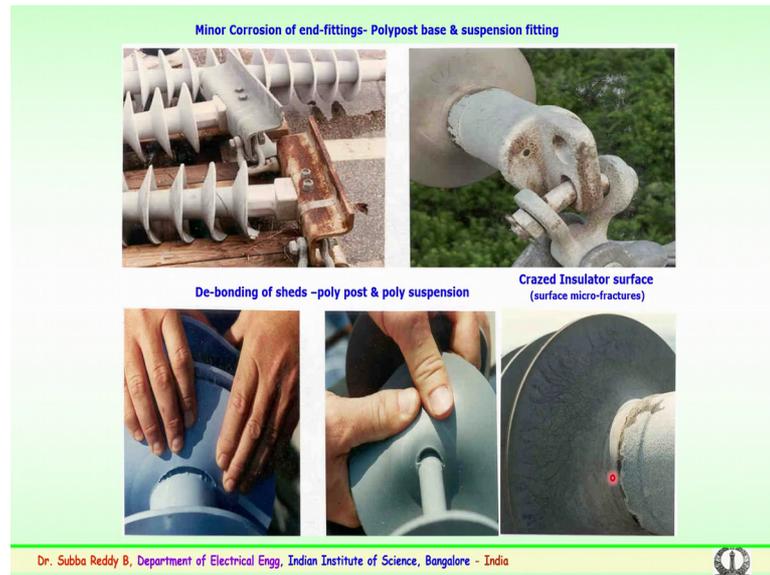
(Refer Slide Time: 22:14)

So, these are earlier polymers, but some of them have the improvements have happened over a period. This again is corrosion because of the end fittings of the polymer rod could lead to the failure of for the insulator string. This is again hardware or clamps which are being used for the terminations and terminations could lead failure over the period of time again. This is a crack rod and these are the older generation of polymer insulator, not the liquid sorry molding machines which are being presently used liquid injection molding machines.

So, earlier the sheds use to be made in a different where it used to be fixed on the surface of the polymer rod such gaps or such cracks will lead to the failure of insulator in the field.

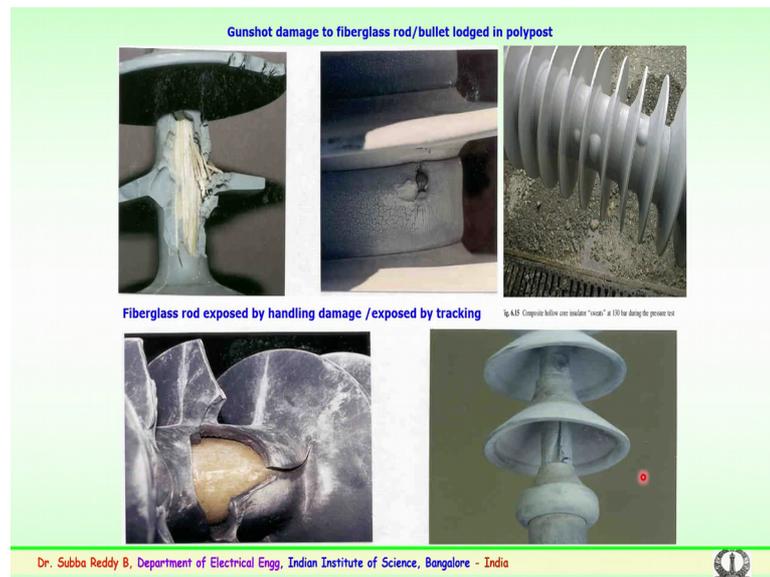
(Refer Slide Time: 23:06)

So these are some of the exposed because of the damage which has happened you can see the fracture or a brittle fracture of the rod, this is due to the likely because of the gunshot or the failure has happen. Here you can see the during the manufacturing stages water bubbles or a air bubbles during the manufacture in case the insulators are being used in a field over a field of time, because of the electrical stress this bubbles could break and the water could (Refer Time: 23:37) into that and the failure is likely to happen.

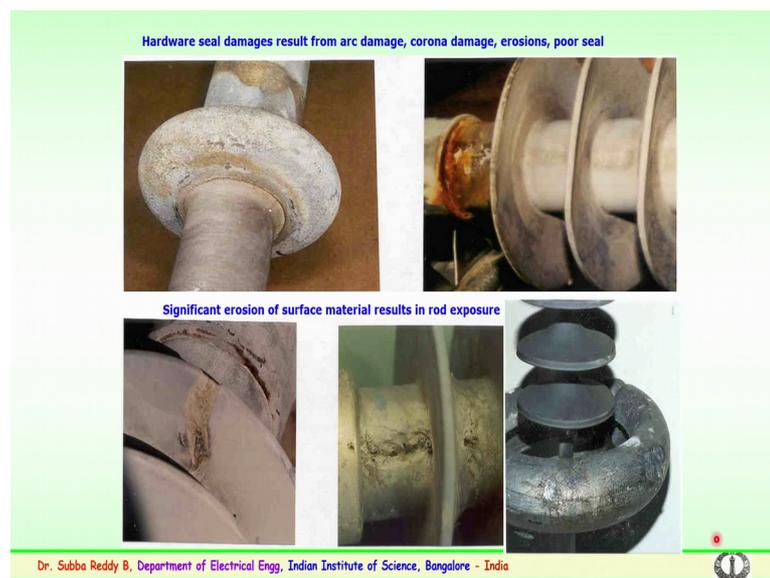
(Refer Slide Time: 23:44)

So, this again are some of the earlier failures of polymer insulators which have been seemed by the utilities. Likewise, these are a failure because of the end fittings which the hardware which is being employed for the polymer insulators. And also this is a corona controlling for the non-ceramic insulator polymer insulator. Over a period of time this insulator if is not properly designed not properly oriented and placed could lead to the continuous discharges, and this discharges on the surface of the insulator could be completely damaging the hydrophobicity effect on the insulator and could lead to the failures.

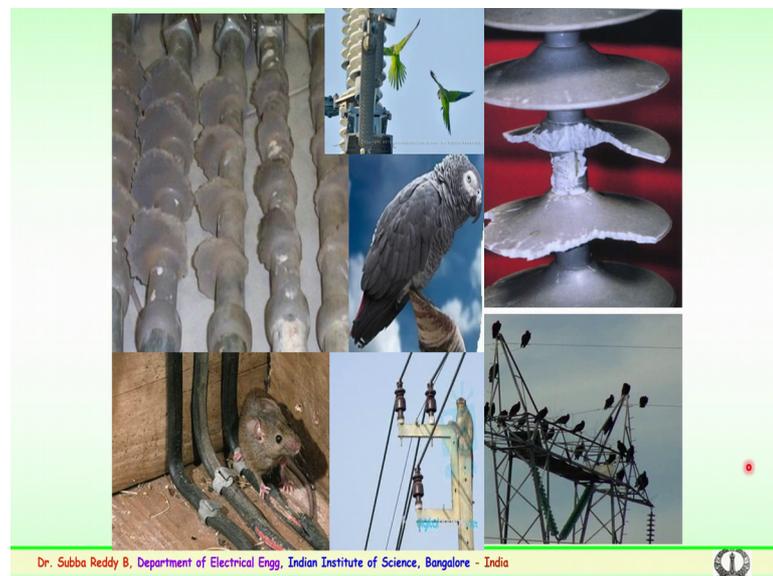
(Refer Slide Time: 24:25)

So these are some of the various failures which are happen because of the electrical stress mechanical and corona related issues, but when you look into this slide it may look strange why this slide has been put. So, this silicon rubber polymer or a porcelain type of insulators as I was mention is a organic material very important to take care. So, sometimes the storing of the material is very important.

If we do not store in a proper way small animals could a try to the insulation could be damaged by these things and also some parrots and huge birds which are normally reside on the tower of the transmission lines would like to peck the surface of the silicone rubber so they could damage the sheds. This is again a issue pertaining to the birds and small animals.

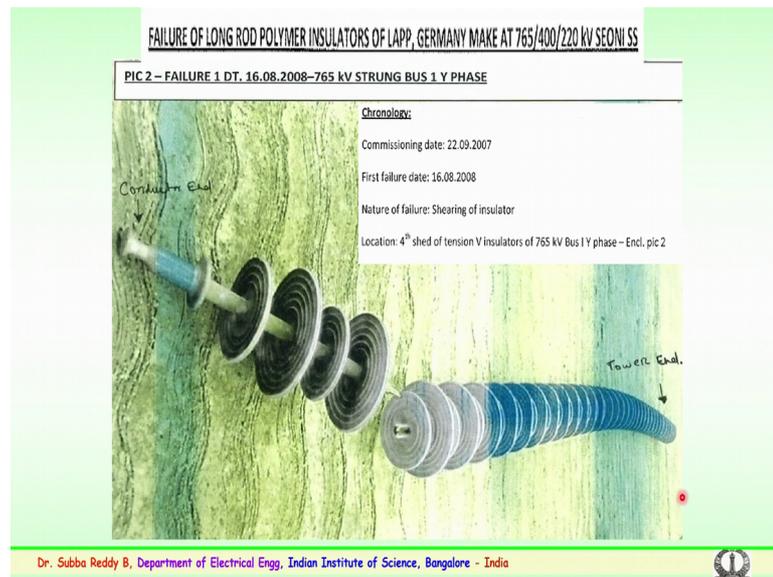
(Refer Slide Time: 25:33)

So, every care has to be taken as compare to the ceramic or a glass insulator. These are to be much more attended in the transmission systems. These are some of the failures which have been reported because of the brittle fracture you can see after the forth shed over a period of time the brittle fracture has happened and that detachment of the insulator has observed in the field so very important.

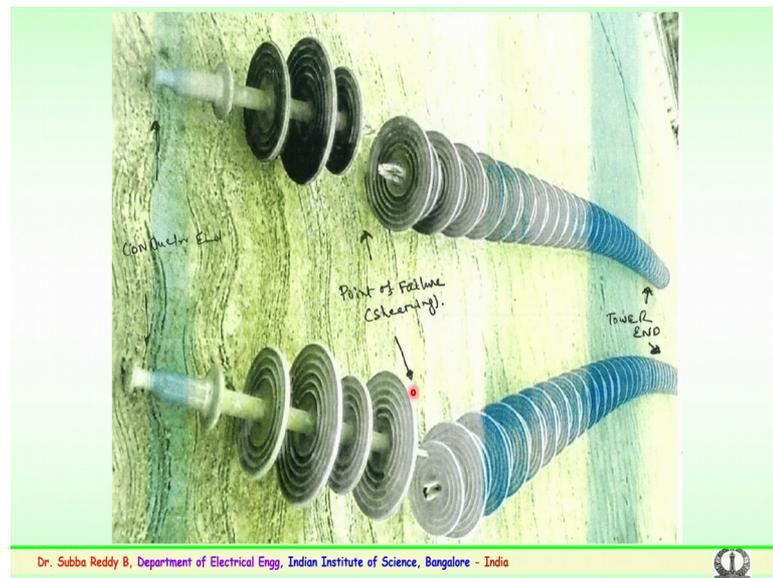
(Refer Slide Time: 26:19)

So these are again various failures which are been noticed over a period of time, and the polymer insulator. This is particularly for one of the transmission system for a 765 KV line we have the tower failure has happened after 8 to 9 months after their action so very serious concern. So, ones the technology which were adopting have to be carefully also looked. So, that equal important is given not only to the material the newer technology the adoption how it is being use, how it is being erected in the field what are the orientation of the corona control dense this has led because of one of reason being the placement design and orientation of the corona control rings.

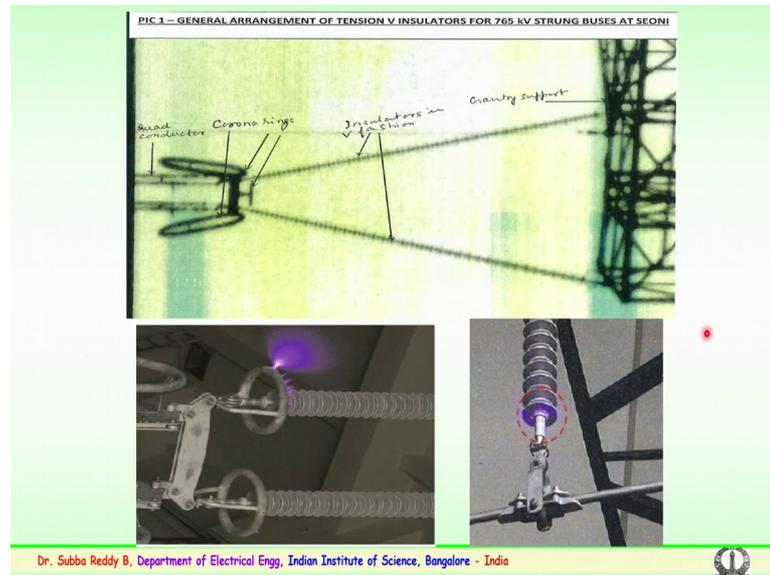
(Refer Slide Time: 27:04)

So, how corona is important why it degrade the surface, yes as you see here the corona comes from the hardware. Here you see from the corona control rings. This corona which is generated the discharges which are continuously discharges are likely to damage the sheds which continuously (Refer Time: 27:25) on the surface of the insulator.

Over a period of time the surface of the polymer insulator which is supposed to be hydrophobic, loses its properties and the surface degrades, and could lead to the failure of the insulation. So, these are some of the hardware fittings which are used for the polymer insulators consist of IO plate arrangement for a double tension string you have a corona control rings with necessary brackets and hardware to fix for the tower end.

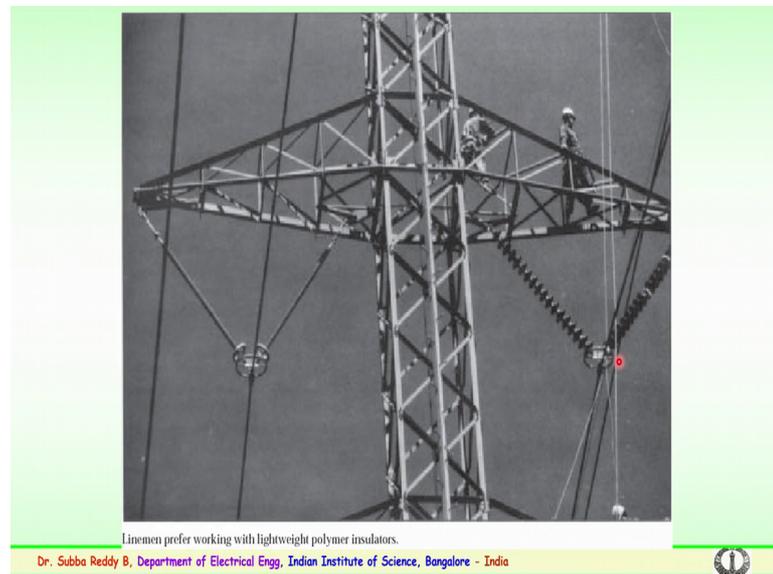
(Refer Slide Time: 32:32)

So, I will compare the working of the technical or technical engineers or technicians in a tower. So, very clearly you can see in case of porcelain insulator for a 400 KV system how much if there 25 days with the hardware the material weight is very high. This shows the polymer insulators with the lesser hardware and lesser corona control rings.
