Advances in UHV Transmission and Distribution
Prof. B Subba Reddy
Department of High Voltage Engg (Electrical Engineering)
Indian Institute of Science, Bangalore

Lecture – 11
HV testing techniques for various apparatus

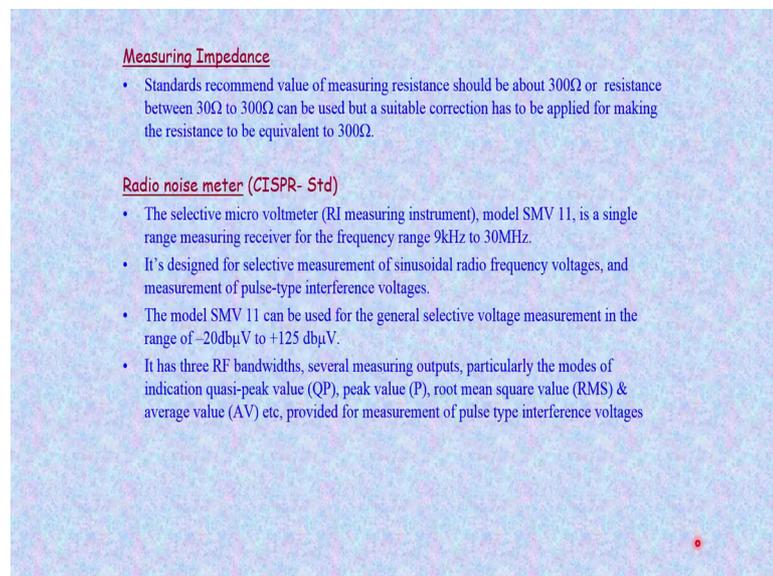
Measuring Impedance

- Standards recommend value of measuring resistance should be about 300Ω or resistance between 30Ω to 300Ω can be used but a suitable correction has to be applied for making the resistance to be equivalent to 300Ω .

Radio noise meter (CISPR- Std)

- The selective micro voltmeter (RI measuring instrument), model SMV 11, is a single range measuring receiver for the frequency range 9kHz to 30MHz.
- It's designed for selective measurement of sinusoidal radio frequency voltages, and measurement of pulse-type interference voltages.
- The model SMV 11 can be used for the general selective voltage measurement in the range of $-20\text{dB}\mu\text{V}$ to $+125\text{ dB}\mu\text{V}$.
- It has three RF bandwidths, several measuring outputs, particularly the modes of indication quasi-peak value (QP), peak value (P), root mean square value (RMS) & average value (AV) etc, provided for measurement of pulse type interference voltages

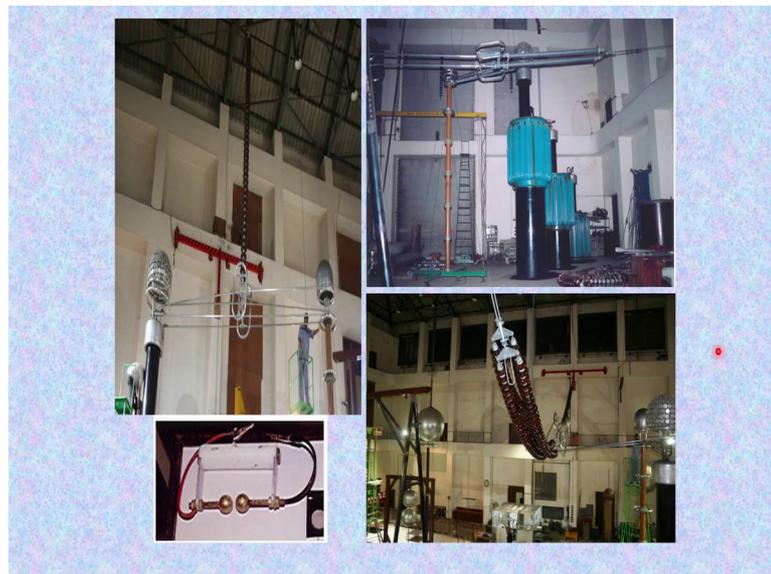
So, these are all the mounting arrangements for various configurations. This is the sphere gap arrangement a small sphere gap of 2 centimetre dia. And the spacing of the gap could be a 4 millimetre in this case, that is a standard breakdown voltage information which is

available in the standard. So, this again measured as per the breakdown of that then converted to the lab conditions, standard temperature and pressure. And it will be connected across each disc we can see here the suspension string is undergoing the voltage distribution the string is connected in a similar fashion as in the field, this is a laboratory simulation with the corona control ring, the insulator number of insulator saying 765 we have 35 insulators in place.

So, the arrangement is similar to the field this is for a I suspension. Similarly, we have for a double tension, and this is for the quarter pole tension. Quarter pole is the 4 insulators connected in a string. That is particularly used for very high voltages and ultra high voltages 765 KV and above. This string has to be simulated as per the field arrangements, you have all the necessary hardware like the uero plate the arcing horns the corona control arrangements, you can see here the corona control rings the end fittings metallic uero plates and other things; so all the accessories similar to the tower configuration where the insulators are strung. So, this is done in laboratory and using the sphere gap arrangement we connect across each insulator disc each insulator disc and the voltage is applied the 5 readings the breakdowns across sphere gap is taken.

So, the breakdown voltage across each sphere gap is made for the entire string, and the values are noted and finally, the distribution is found out. This helps in proper design whether the design of the corona control rings which have been done are properly grading the entire string or the arcing horns or other arrangements. So, which are being used for grading ring are properly designed.

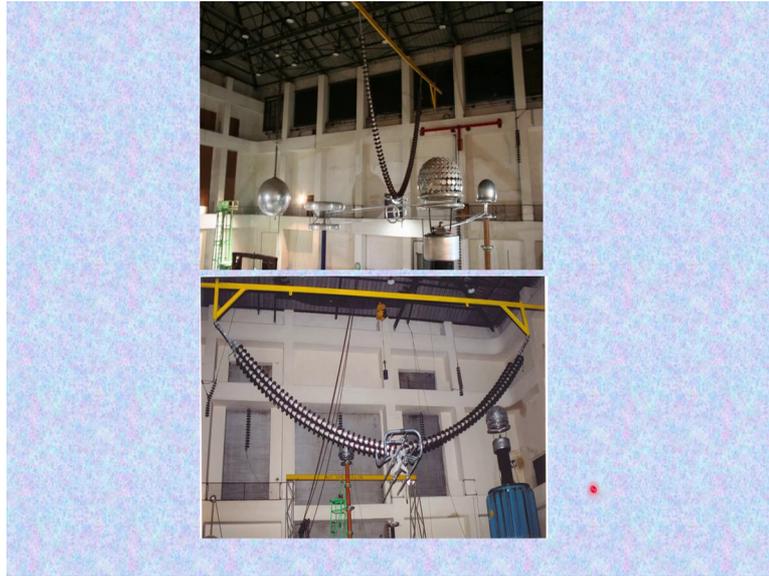
So, this is again different configuration we have seen here I suspension or a pilot string. We have a double tension arrangement, a similar to the field we have a quarter pole that is the 4 insulators string in the field. Here is a v configuration single v configuration and this is a double v configuration. So, these are some of or most of the configurations which you normally encounter at high and very high voltage levels.

So, you see the similar configuration have to be arranged, this a bar is like a tower where the tower to the tower insulator strings are connected with the necessary hardware this is again corona control arrangement rings for the double suspension v string. So, with the conductors which are phone numbers here, as in the field the simulation has been done then the voltage distribution will be measured across each disc from this is a line and which is connected to one million volt a transformer here. So, from here, we apply the voltage and see the breakdown up to the ground level and estimation is a done.

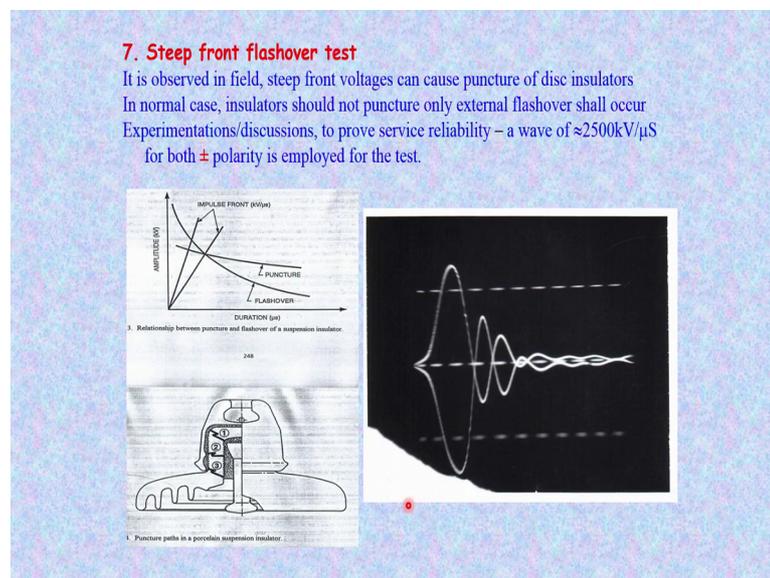
So, this is the steep front flashover again very important reliability test which is carried out for the extra high voltage or ultra high voltage transmission insulators. So, it is observed in the field particularly the steep fronted voltages very steep fronted voltages. Could cause puncture on the disc this puncture on the disc, particularly on the ceramic here it could cause a puncture. So, in normal case insulators should not puncture. Only

external flashover could happen that is external flashover from this metal to the pin on the surface flashover. So, surface flashover could at happen and the insulator again it is properties.

Whereas in case of puncture the insulator completely degrades, it is insulating properties where it has to be changed in the field. So, the external flashover could occur and to prove the service reliability, particularly for very steep fronted impulses a wave of 2500 KV per microsecond is normally recommended by the standards, that is for both the polarities were in the positive polarity as well as the negative polarity a wave of 2500 KV per microsecond is prescribed, where all the insulators have to be applied with this steep fronted pulses and that has to be verified whether this could be stand this stress.

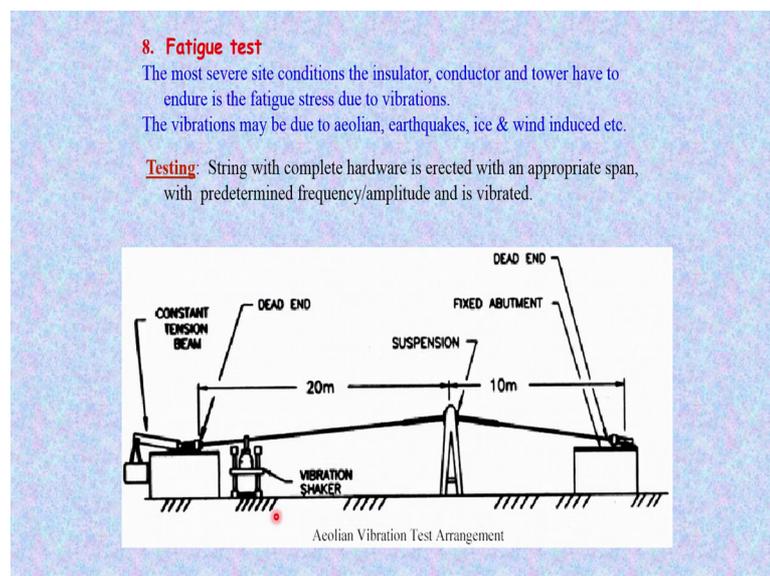
Next is the mechanical fatigue test for the insulator string particularly for the area very important mechanically the tower between the tower the insulator string are connected with help of a conductors. So, the most severe site conditions the insulator or the conductor and tower have to ensure a renewed in the fatigue stress, normally this is because of the vibrations. So, there are again vibrations because of a breaking used vibrations or a galloping or other type of a aeolian vibrations which could be seen by the insulator string in the field. So, these vibrations could be as mentioned like aeolian or due to earthquake or due to ice and wind at that area where the transmission towers are being put up.

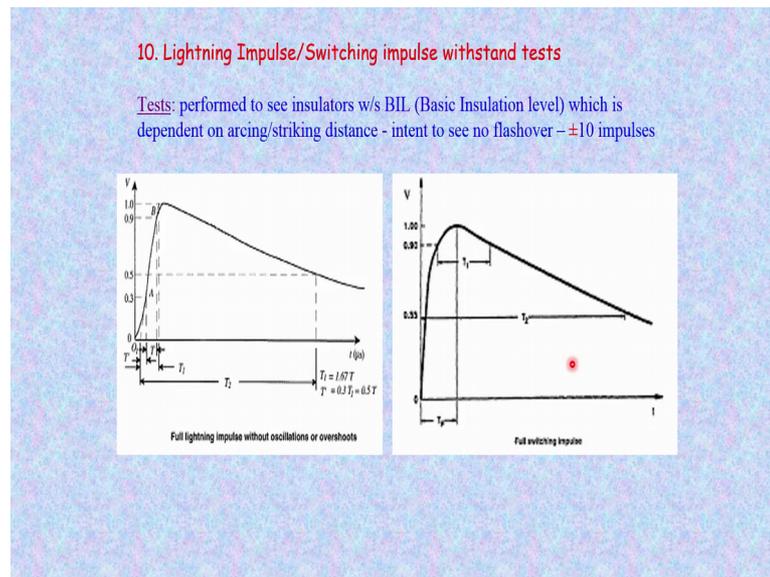
So, earlier we have discussed. So, I would not go deep in to these lightning surges and switching surges. This is one of the mandatory tests which have to be carried out for EHV and UHV transmission components, insulator strings line hardware transformers and other equipment, switch gear equipment.

So, these tests are performed to see in case the insulator string example will withstand the basic insulation level which is provided. So, again the basic insulation level depends what is a voltage level which is being operated, depends on arcing or a striking distance. Main is to intend is to see that no flashover, particularly when you are applying either impulse lightning impulse or a switching impulse lightning impulse, again I will be repeating here lightning impulse is for a duration of 1.2 by 50 microseconds, that is front time is one point 2 microsecond till time is 50 microseconds till this. And for switching the front time is 250 microseconds and the till time is 2500 microsecond, which sim this lightning impulses or lightning surges, similar the natural lightning and the switching impulses or a switching surges simulate the conditions like closing or opening of the circuit breaker or because of the switching actions which normally happen in the power system network.

So, these pulses as per standard the impulses to be applied to the equipment under test, both for polarity there is a positive and negative polarity, of a specified 10 impulses or 10 surges are applied. And during this period the insulator string should not flashover that is

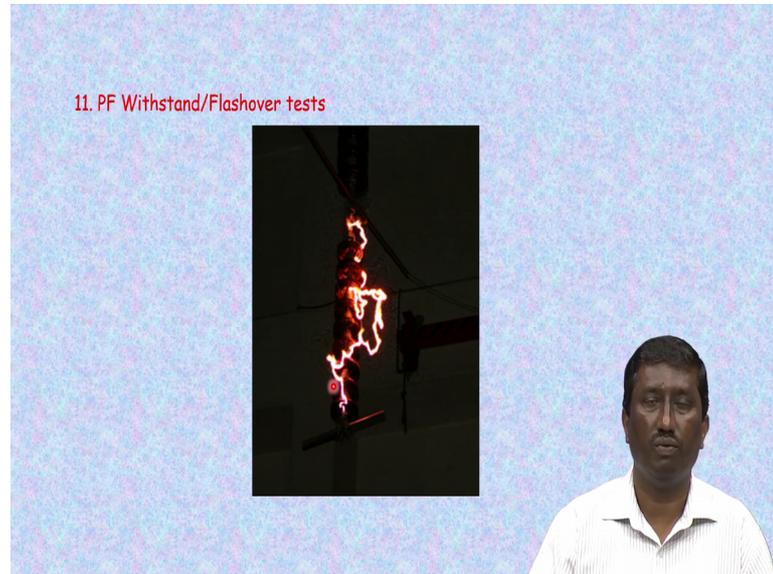
So, after withstand of the earlier test impulse, this is for the power frequency. That is a normal operating 50 hertz frequency. Where the insulator strings will be subjected to the flashover. Say for a 200 or a 400 KV as mentioned, the volt number of insulators remain in case of 213 to 15 and for 400 it is 23 to 25

So, similar arrangement again with the help of the conductor connected to the tower and all the corona control rings arcing horns will be placed similar to the field condition, and the voltage the power frequency voltage the high voltage at 50 hertz will be applied to the conductor and will be raised as a in steps up till the flashover or the entire surface flashover happens between the metal that is a ground end to the high voltage end.

So, this again flashover withstand value. So, what is the flashover before power frequency, flashover how long it could be stand in the field, the design string is checked then the flashover is applied and it will be also verified where the insulator string flashes and what is a maximum insulation limit which it can offer. So, these withstand and flashover tests are usually conducted for both that is a dry conditions as well as for the wet that is a rain conditions. So, dry and wet power frequencies withstand and dry and wet power frequency flashover test are normally conducted for the insulator in strings in the EHV and UHV levels.

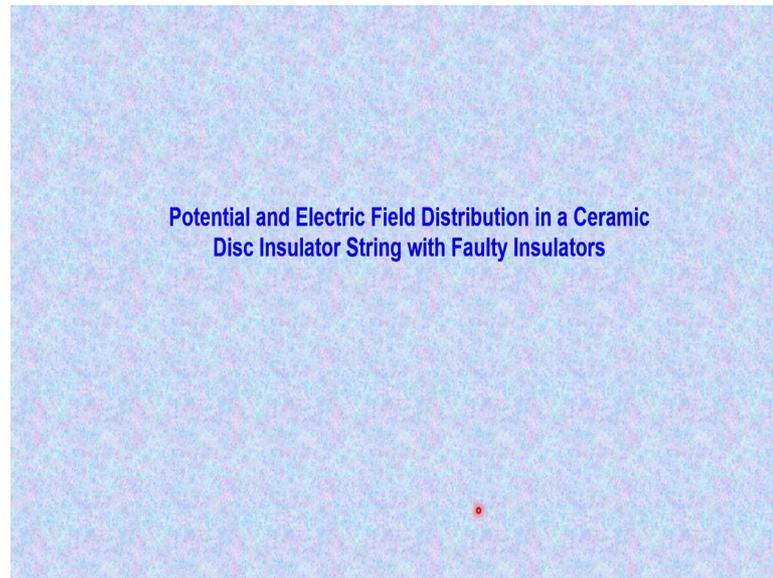
So, I we were discussing with the type test, what happens to the field and electric potential and the electric field, how it gets modified, how it gets distributed. Particularly in a ceramic disc insulator string, if the string contains a faulty insulator. Again the faulty insulators could be in the string any position on the string. So, this could be happened because of the failure of insulators due to attention loads or because of inherent property of the insulator which could I have failed over a period of time losing it is insulating properties.

So, in case the insulator position where the failure as happened is very important, so studies we have try to analyze and conduct some experimental studies on this how the potential gets modified with the particular location of fault insulators being in the string. So, we will be seeing in that with the fault location also along with the potential, the electrical field distribution the electrical stress distribution across the insulators which are adjacent to the fault it is how it gets modified.

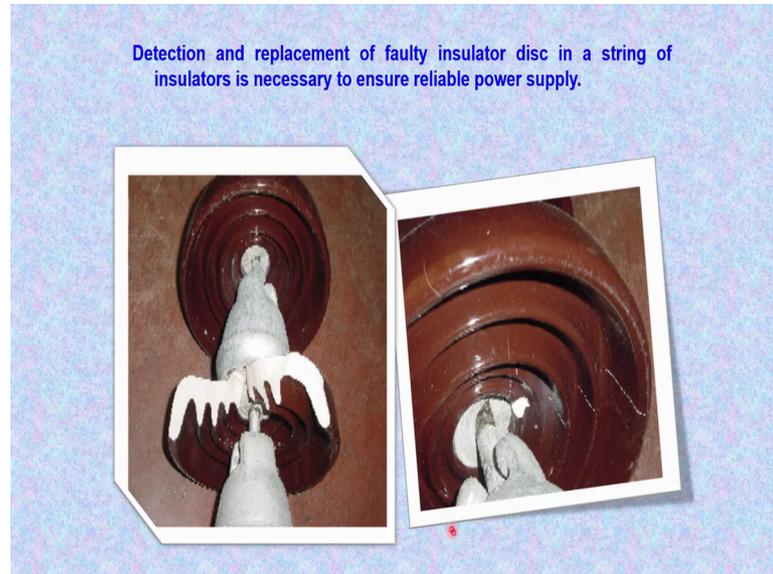
So, here this shows detection and replacement of how a faulty insulator in a string is normally carried out. This will ensure for the reliable power supply. You can see there are faulty disc which are physically observed. So, in that case it is easy to replace the insulators, by there are some instances, where physically the insulator failure could not be seen. There could be cracks or the puncture which could have happened it is difficult to observe through the naked eye. In such case the modification of the field and potential could drastically change.

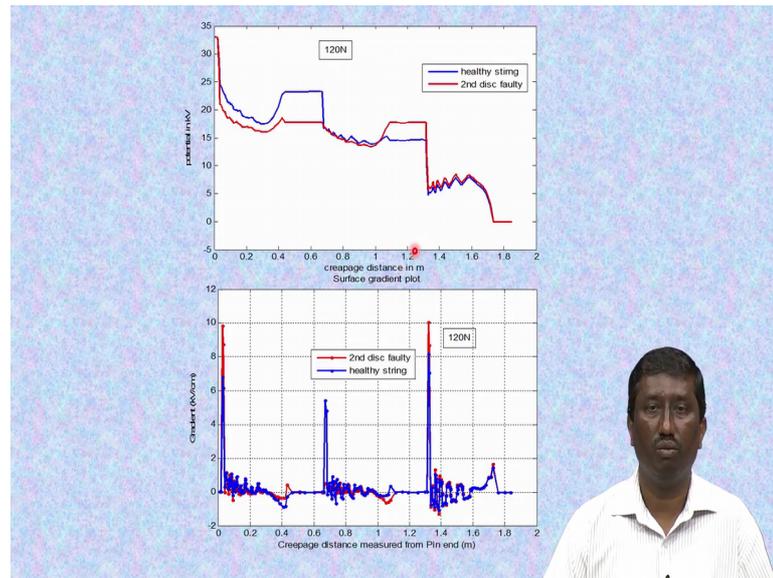
So, we have a try to see how the potential behaviour or a performance in case of a simple we start with a example of a simple 3 disc insulator string. So, 3 disc this each you can see is one disc is connected at 33 KV intentionally 33 KV potentially is applied. You see the 33 KV potential and second is at 20 KV or 22 KV is not uniformly distributed and third insulator is here and which is connected to the ground and the cap of the third is connected to the ground end.

This is how a typically insulator string when we there are several methods to numerically analyse this. There are finite element boundary based elements which has methods. So, we have tried to use a surface charge simulation method for the work and we have try to plot the potential field and also to see the faulty disc in case if there are present in the string, how this faulty a discs could lead to the change in voltage distribution.

very clearly there is a drastic fall in the voltage here, because this and the third one are at the similar potential. So, the entire potential distribution gets modified and the potential across the first insulator and sometimes across the third insulator depending upon the tower to ground capacitance and capacitance to ground depending on number of insulators gets completely modified, which is shown here. You can see suddenly there is a rise in electric stress across the first insulator and the third insulator.

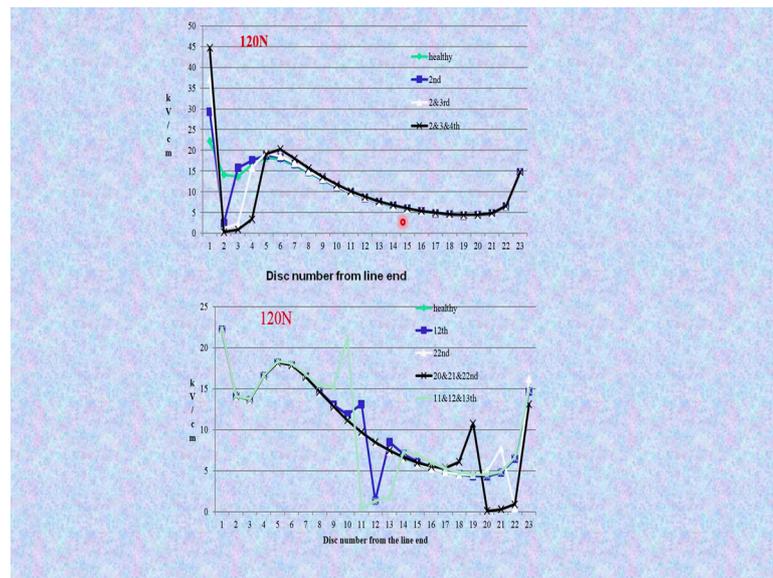
Similarly, if there are discs which are faulted at various locations, the study has been conducted. This is for a 400 KV transmission insulators string where actual consideration as per the field condition is taking into the corona control ring and necessary hardware the simulations have been carried out and the graphs show here, the green colour graph indicates for the healthy conditions. And you see the second insulator in case second disc from the line end is faulty how it gets modified. Similarly, if there are faulty in locations of other insulator disc, which are different locations the potential gets modified at that particular location and the adjacent disc see higher stress or higher voltage distribution which is observed.

So, various locations the faults have been intentionally created, and the distribution change in distribution pattern has been presented here, for different disc. This is for 765 or ultra high voltage transmission towers.

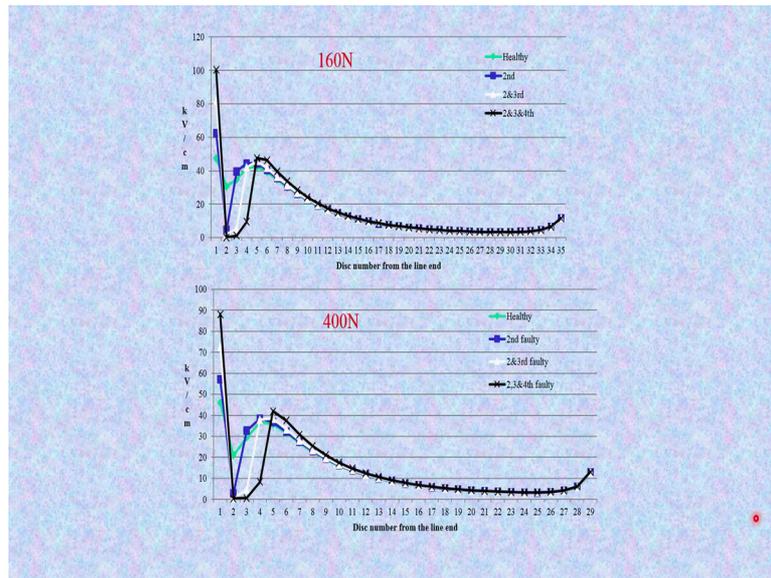
So, what happens in case the faults are at different junctions considering the faults at second insulator, considering the fault at different location arbitrary, we have try to see that how much potential or how much field modification happens, this gives an idea in case there is a fault at that location the adjacent insulator sees a higher potential or a higher field, which could be estimated whether it is at it is a dangerous limit. So, that immediate change is required or it could be allowed for some more time.

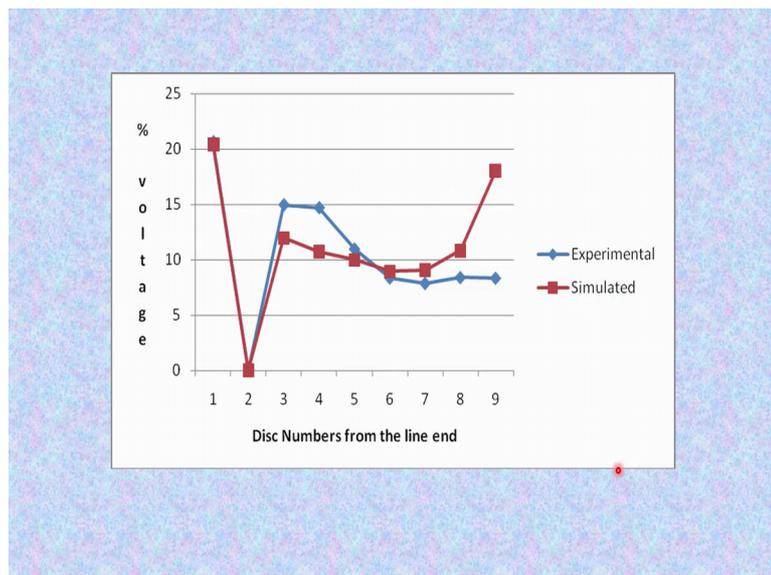
So, this is an experimental and a simulated graph, which has been carried out in the laboratory for 132 KV systems. So, 132 KV you have 9 disc in a string. So, both the simulated values are indicated in the red curve here. You can see the experimental curve here. So, experimental we have shorted the actual insulator when we are considering the failure of that insulator, we have try to see that that particular disc has been completely shorted. So, that it is acts like a fault in the string. Then the experiments are repeated for a various possibilities various fault locations and it has been compared with simulation results.

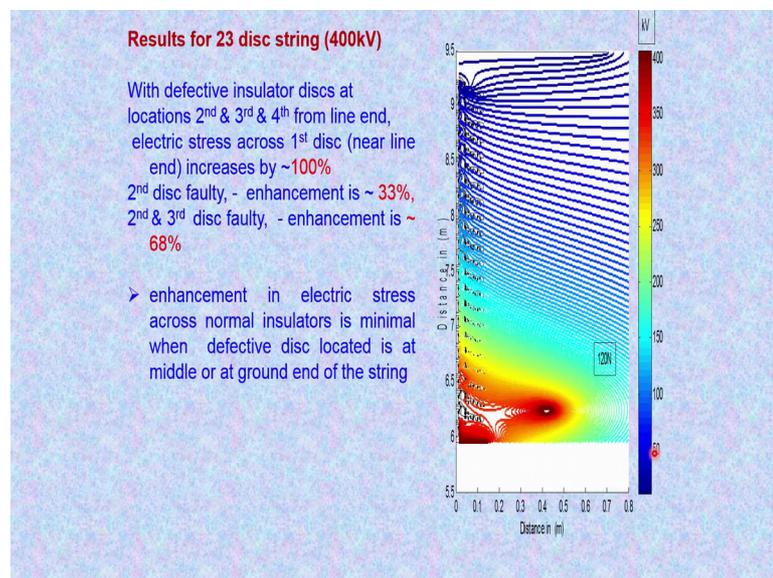
So, this gives idea for 400 KV in case the earlier results. In case there are defective insulators at the location say this is the high voltage end these are all the insulators this gives an equi potential plot arrangement here. So, these red indications are the corona control rings and other accessories which are connected near the line end. This is the line end which shows the insulator string is at a particular height of 6 to 7 meters which has been considered for simulation.

So, you see the defective insulators which are located intentionally, we have try to simulate the faults at second third fourth, from the line end line end is here the disc from the second third fourth are intentionally created a faults. If that happens, so what will be the stress which is going to be near the first insulator that is immediately after the line end? So, you can see here the electric stress across the first disc increases more or equal

to 100 percent. So, whatever the stress which it use to earlier see if there are faults or the insulator second third fourth are a faulty in nature, the stress will be doubled across the first this will hamper the performance of the insulator where the insulator is likely to shutter or there could be a failure or the entire string flashover could happened.

So, this gives an idea if there are faulty disc. So, that has to be immediately rectified. So, similarly fault locations at arbitrary have been chosen, and we have try to estimate the faults of the insulators for various string configuration. So, here you can see other example. In case if not second third fourth only the second insulator disc is faulty. Then the field enhancement is around 33 percent or in case if the second and the third are faulty enhancement is 68 percent. So, you can see that in case 3 are faulty it is 100 as the number of discs are reduced the percentage of stress also decreases. So, the fault plays a role how many insulator disc are faulted play a role and the location play a role. So, location how far from the line end that is very important or factor to be noted.

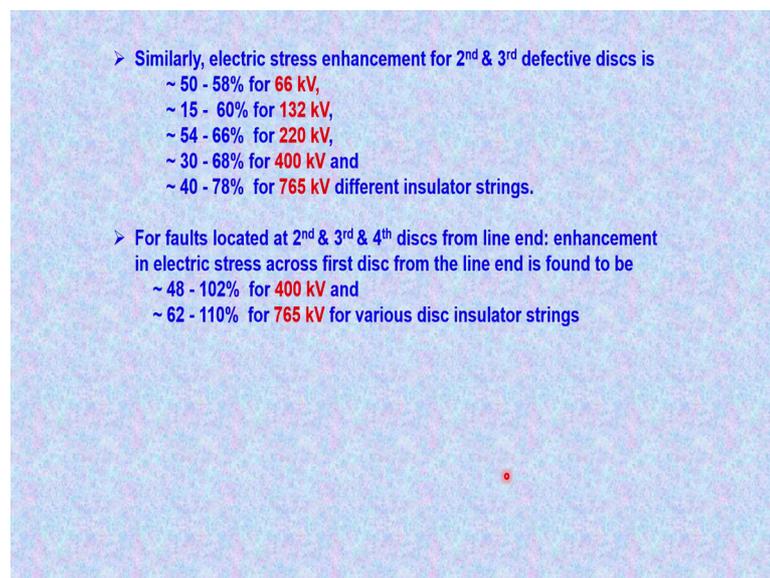
So, similarly electric stress enhancements for different voltage levels have been calculated from 66 kilovolts to the ultra high voltage range. You can see in case there are faulty disc at second and third from the line end. The percentage increase of the stress for a 66 will be 50 to 58 percent this goes on up to 78 percent in case of ultra high voltage. So, very important point; so physically if there are failures or fault locations which are to be observed. The next or the adjacent insulator sees an increase of 78 percent which is

not advisable for a longer period the utility engineers have to be immediately questioned and see that or the changes have to be made. Similar fault locations at second third fourth show this values for 400 or 765 KV how the stress increases with a adjacent insulator discs.

Table: percentage electric stress across the first disc from the line end in a string with defective insulator discs in different location

So, this gives a complete percentage of the electric stress across the first disc. Particularly we have taken the first disc is functional, the first is disc is functional there is no failure. The consideration was second could be a faulty which is a very serious thing. In case second and third faulty or in case of second third and fourth faulty these are the values of percentage stress which the first disc sees that is very important.
