**Failure Analysis & Prevention**  
**Dr. Dheerendra Kumar Dwivedi**  
**Department of Mechanical and Industrial Engineering**  
**Indian Institute of Technology Roorkee**

**Lecture – 39**  
**General Procedure of Failure Analysis:**  
**Examples of Failure Analysis**

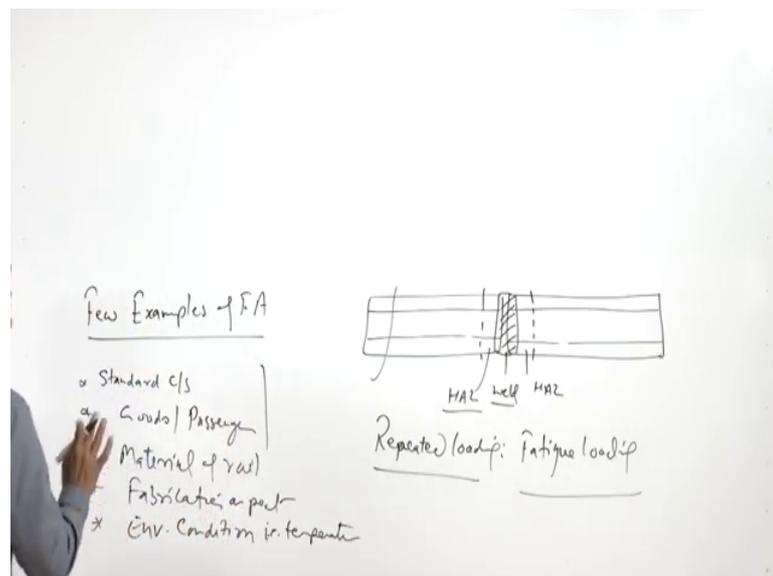
(Refer Slide Time: 00:47)

So, now here today we will take up the few examples which can be used just to have idea about how do we proceed for the failure analysis and how to make; how to investigate the different aspects related with the possible causes of the failure. So, few examples of the failure analysis, say I will take one typical example say there is a rail and the rail this is the I section of the joint and here it is joint using the thermite welding process and the joint is like this.

So, thermite welding process which uses the molten metal created through the exothermic reaction and this molten metal fed in between the gap of the rails gap between the rails and which after the solidification results in the joint. Around this some

kind of the heat affected zone is also formed because the heat gets transferred. So, there is a heat affected zone and there is a weld and heat affected zone is found basically both the sides. So, it is common that the many railway accidents take place due to the fracture of the joints or fracture of the rails. So, there can be both the possibilities fracture can occur from the rails or fracture can occur from the heat affected zone or the weld area.

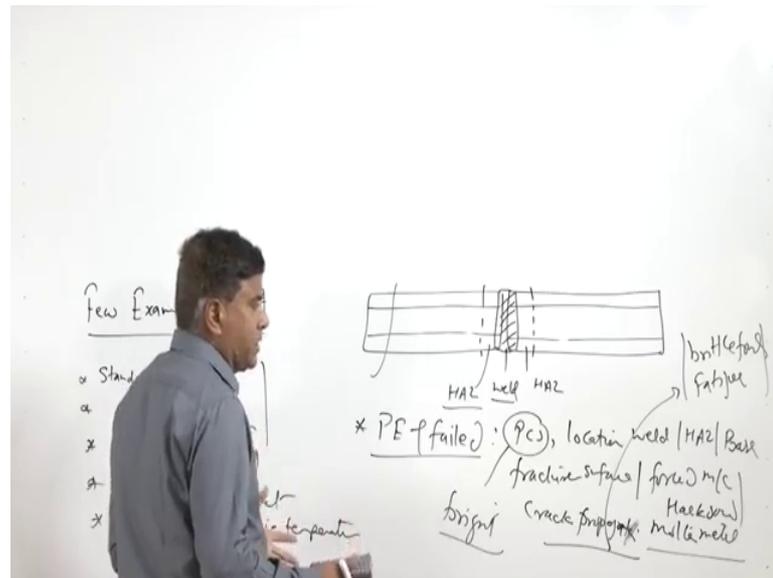
(Refer Slide Time: 04:26)

So, in the in case of the failed rail what we have to basically observe the pieces of the broken rail and then we have to see the location where from it has the failure has occurred, whether it is from the weld from the HAZ or from the base metal of the rail; then there is a possibility of the tempering of the these rails.

So, we have to see that the fracture surfaces, if they have any special kind of the marks which are reflecting in form of the forced machining like use of the hacksaw; kind of the blade for cutting purpose or some kind of the flame has been used for cutting. So, there will be molten metal on the fracture surface, so all these things can be easily checked and if it has happened we can easily establish that.

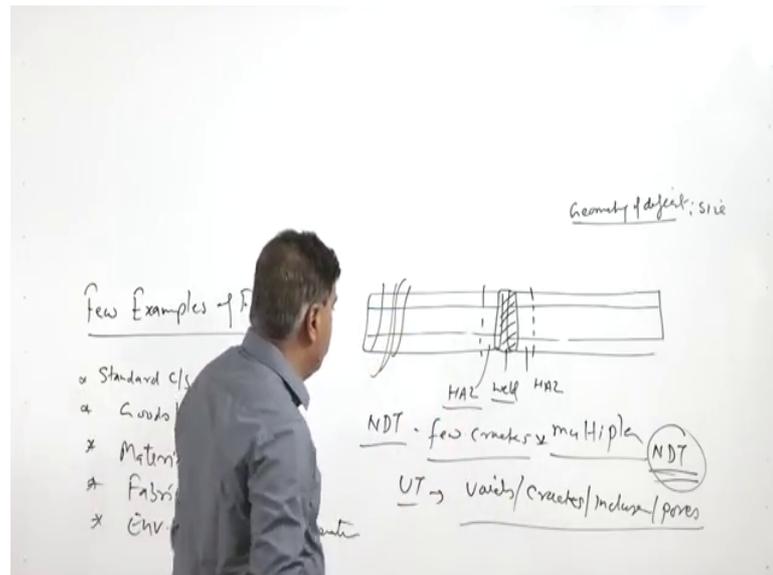
(Refer Slide Time: 07:03)

In NDT we will try to see if near the fracture areas few cracks were present, some times in the fatigue conditions especially the multiple cracks are observed near the fracture surface. So, but so if that is the case then it will be revealed under the NDT test or there is also possibility of there is this is.

So, multiple cracks will be revealed through the NDT or NDT like ultrasonic testing will indicate near the fracture surfaces, if there were some voides which have create have been created below the surface or some cracks were present inside cracks, inclusions or pores are present in the rail. So, these things can be identified say if the this is the failure location then UT and DPT etc, can be carried out to see near the fracture regions to investigate if there is really presence of this discontinuities or not.

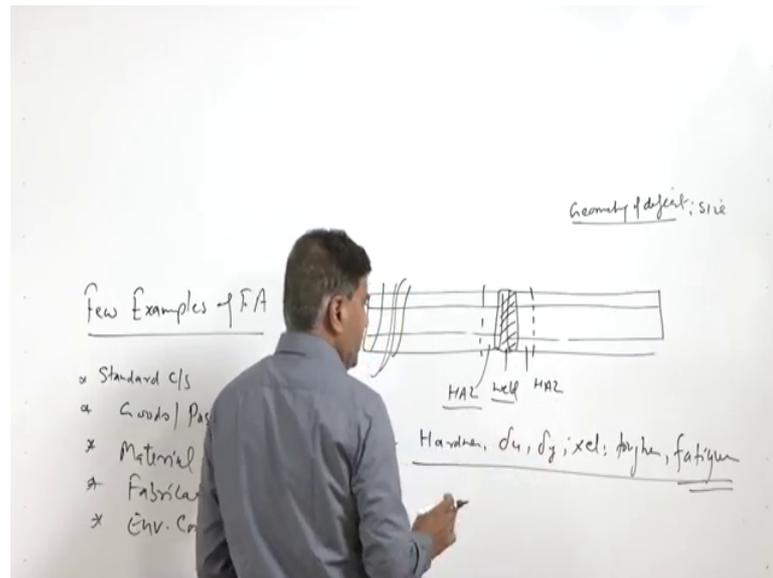
(Refer Slide Time: 08:47)

So, destructive tests are conducted for that purpose and we will be trying to identify the hardness, hardness test ultimate strength yield strength percentage elongation toughness and if possible if you sufficient it means for that purpose since the rails will be subjected to the fatigue loading.

So, it will be good idea to perform the fatigue test also to in or in order to see the resistance to the fatigue loading. And the data for the mechanical properties will be generated on the rails, to see how about the mechanical performance of the rails. So, this these properties will be identified and will be determined and they will be subsequently related with the fracture possibilities.

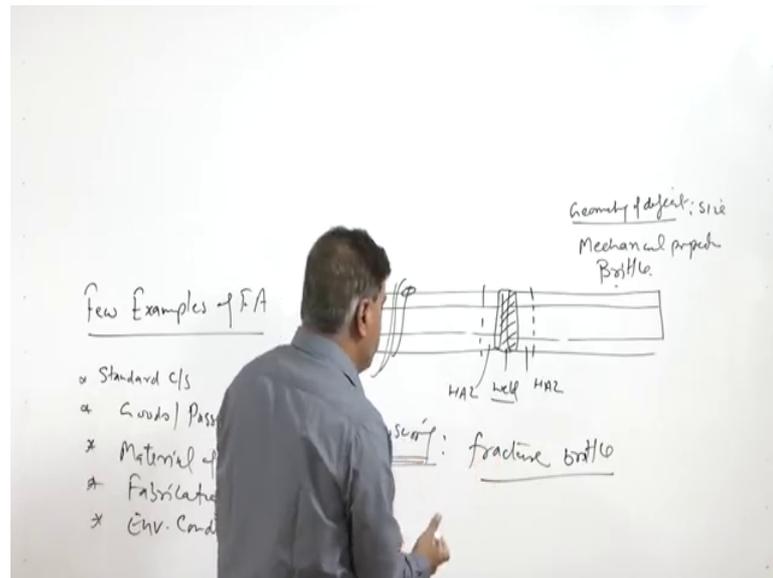
(Refer Slide Time: 09:42)

So, whether the material is the tough or the brittle, so mechanical properties will be established. So, they are after what we will be doing we will be doing the macroscopy of the fracture surface, which will indicate the fracture initiation site which may be at the surface or below the surface. So, if the fracture is initiating from the surface it will have its own unique features present on the surface and it may not be, there may not be any unique feature present at the surface.

So, there is say there is no unique feature present or the on the fracture surface and the fracture fracture is the brittle and without any deformation. So, no deformation will indicate that the fracture is the brittle in nature. So, this is one of the possibility we can consider through the macroscopy; the bright signing fracture surface with no deformation indicating that it is a brittle fracture.

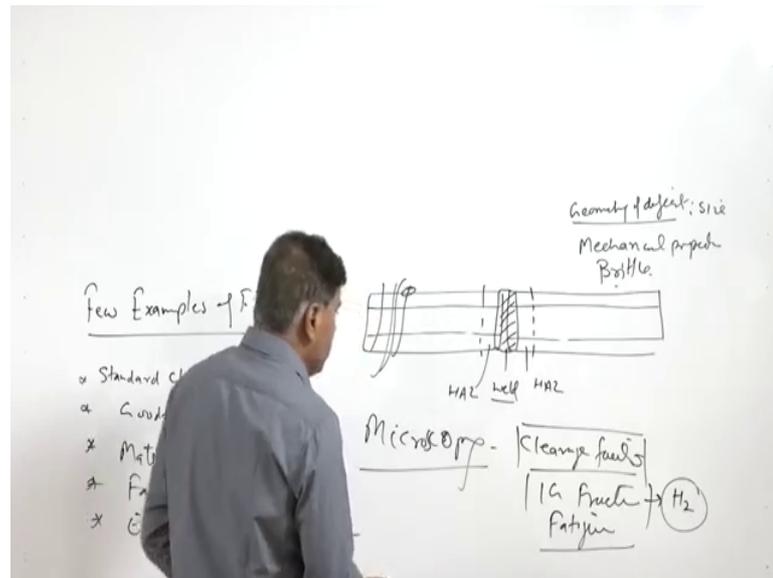
(Refer Slide Time: 11:16)

So, it may be the fatigue fracture also so if there are (Refer Time: 11:26) present that will indicate the possibility of the fracture by the fatigue, if there are intergranular fracture then it will present the possibility of the source of the cracking like the hydrogen embrittlement or the hydrogen induced cracking or if there is a just simply cleavage facets are there, then this is a overload fracture. So, microscopy will be revealing these microscopic fracture mechanisms and accordingly this will be used as a basis for the analysis subsequently.

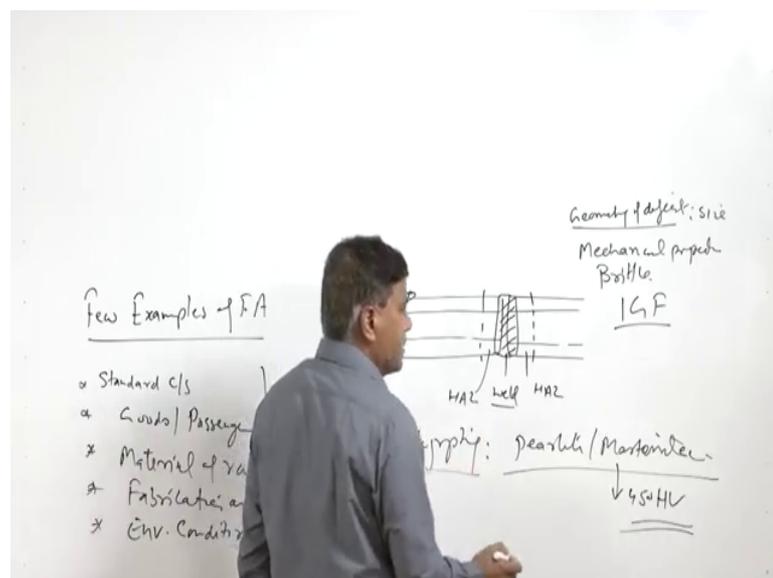
(Refer Slide Time: 11:56)

Say If it has revealed intergranular fracture then that also will be recorded, after that we will be seeing the metallographic aspects of the failed component, metallographic aspect of the failed component and it is a metallography suggest that no it is very perlitic and martensitic structure and martensitic structure and so and it is having the hardness of the like say 450 HV.

So, wickers hardness in of the 400 HV is the is on the little bit higher side, if that is the case either due to the presence of the fracture surface near the heat affected zone or in the weld metal or in the base metal due to the segregation of the certain elements if the hardness is on the higher side, so that will be that will also be recorded.

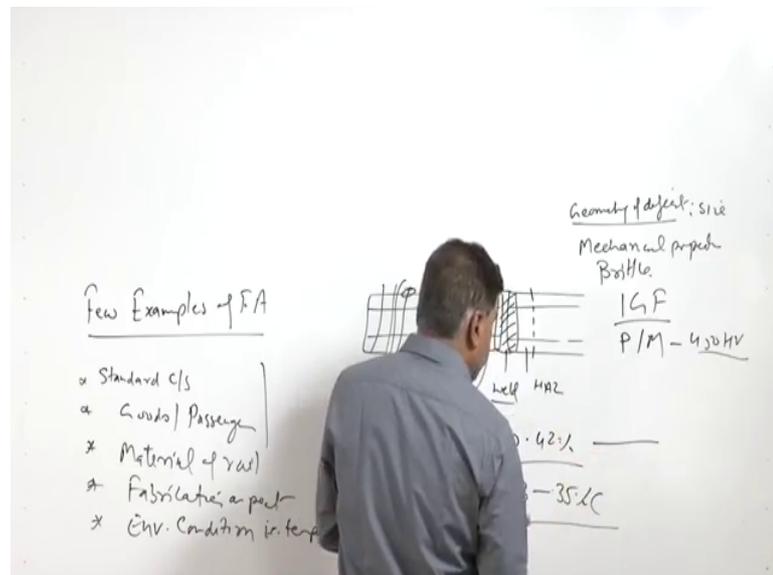
(Refer Slide Time: 12:51)

So, the perlitic martensitic structure with the hardness of the 450 hardness then that will be coming to the chemical aspect. So, the chemistry of the rails if that is investigated and chemistry if it may confirm or it may be on the higher side or the lower side. So, if the chemistry say coming out 0.42 percent carbon, so think that it is a medium carbon steel with the other residual elements while it may be the recommended range may be 0.32 0.5 also percentage carbon, so but if it 0.4. So, it may be say on the higher side which will be leading to the little bit higher hardness.

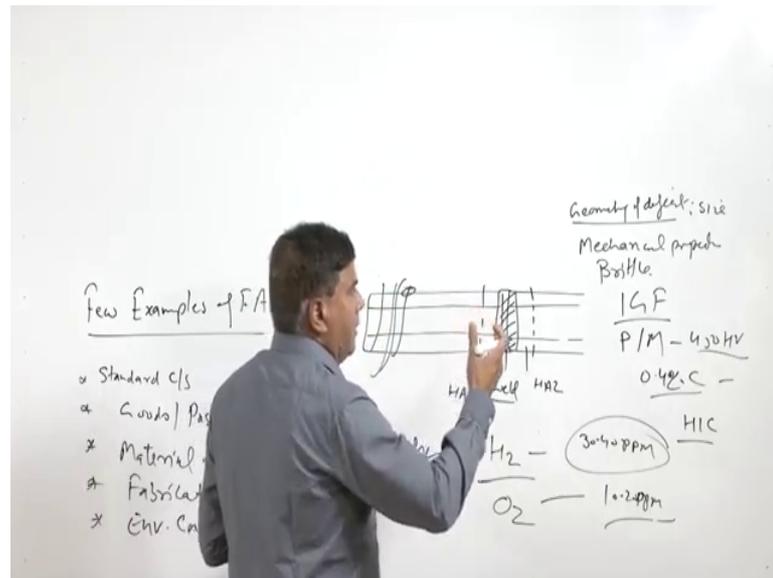
(Refer Slide Time: 13:39)

So, we will be recording that let us say the carbon content is 0.42 percent with the presence of other residual elements, which will be leading to the like say the higher hardness presence of the perlitic and the martensitic structure especially in the head affected zone and then apart from this we can do some gaseous analysis of the of the failed rail. So, the gaseous analysis may indicate the presence of say hydrogen or oxygen hydro oxygen, if it is like say 10 to 20 pm it may not be that harmful. But if it is like say 30 to 40 PPM for the hydrogen, this can create the trouble especially with regard to the hydrogen induced cracking, this can propagate the cracks through the intergranular fracture mechanism and cause the fracture.

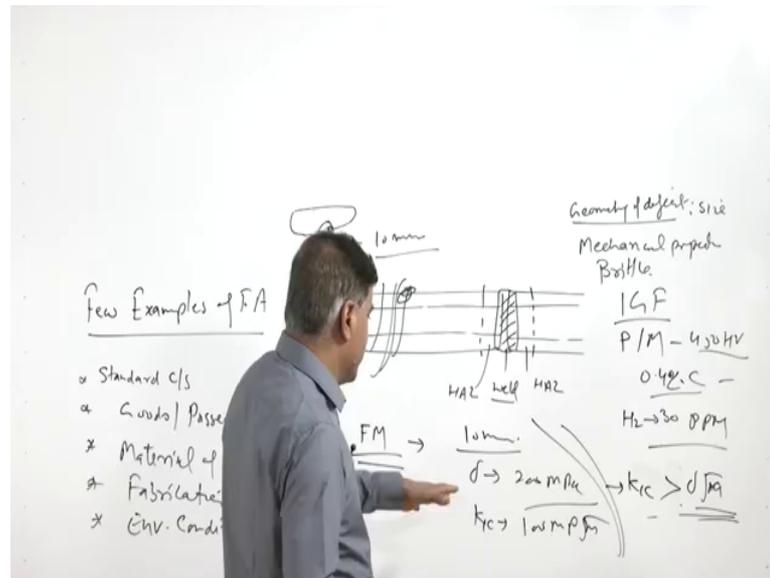
(Refer Slide Time: 15:39)

So, hydrogen gaseous the means I mean to say that the hydrogen or the gas analysis will indicate what are the gases which are present. So, say hydrogen is 30 PPM hydrogen is present and after that we can do the fracture mechanics analysis and fracture mechanic mechanics analysis, if suggest that there was a some kind of the crack which was present because the fracture surface; like the fracture surface showed that in the rail like this and there was a crack which was present and this was dull and this crack was especially present in this area of say 10 mm size.

So, what we can do using the fracture mechanics concept the open crack of the 10 mm size and the services stress conditions sigma say if it is 200 MPa, if that can be calculated through the loading conditions and then the fracture toughness of the material  $k_{1c}$  can be easily obtained or characterized and say if it is coming 100 MPa raised to the power 1 by 2. So, using this we can simply correct establish if the this kind of the crack really can be critical or not. So, the cruciality of presence of discontinuity and it is role on the fracture can be easily established and thereafter we can say really if this can contribute towards the catastrophic fracture or not.

So, if the if the value of the  $k_{1c}$  is less than the  $\sigma \pi a$  then it will indicate it has contributed significantly, in the fracture and if the  $k_{1c}$  value is lower than the  $k_{1c}$  value is  $k_{1c}$  value is greater than the  $\sigma \pi a$ , in that case we will we will see that we will conclude that though. Now the role of the discontinuity means the crack and the

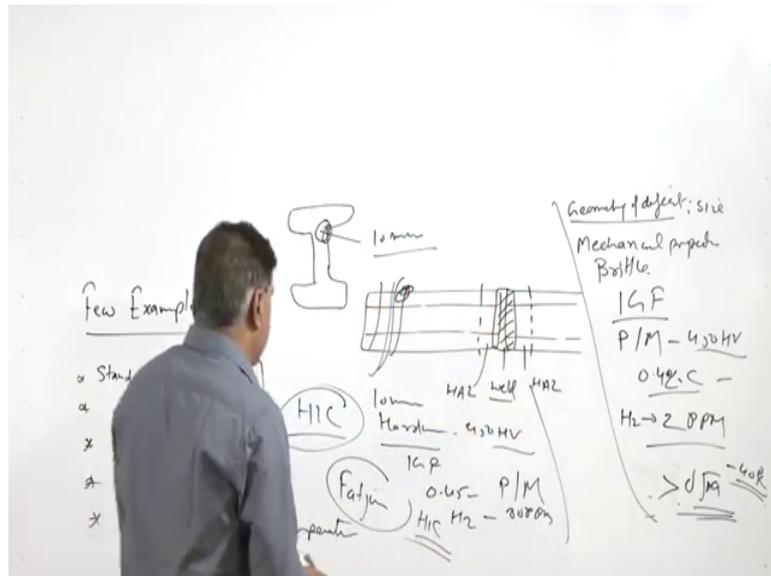
(Refer Slide Time: 17:12)

We have done the fracture analysis, hardness from mechanical properties hardness is coming out to say like 450 HV and it is the intergranular fracture and the carbon content is 0.45 leading to the perlitic and martensitic structure, hydrogen is also on the higher side 30 PPM.

So, all these factors are indicating that no the crack the fracture has not contributed significantly by the presence of crack, but the presence of the hydrogen has lead to the gradual growth of the crack, due to the presence of the hydrogen and the hydrogen induce the cracking or the delayed cracking subsequently under the repeated loading conditions lead to the growth of crack up to the certain fracture stage. So, it is it will be basically the fatigue fracture which will be facilitated by the hydrogen induced cracking. And if there is there is another possibility that that the temperature conditions were too low to and if the hydrogen is not say there may be another scenario when the hydrogen content is very low say it is 2 PPM.

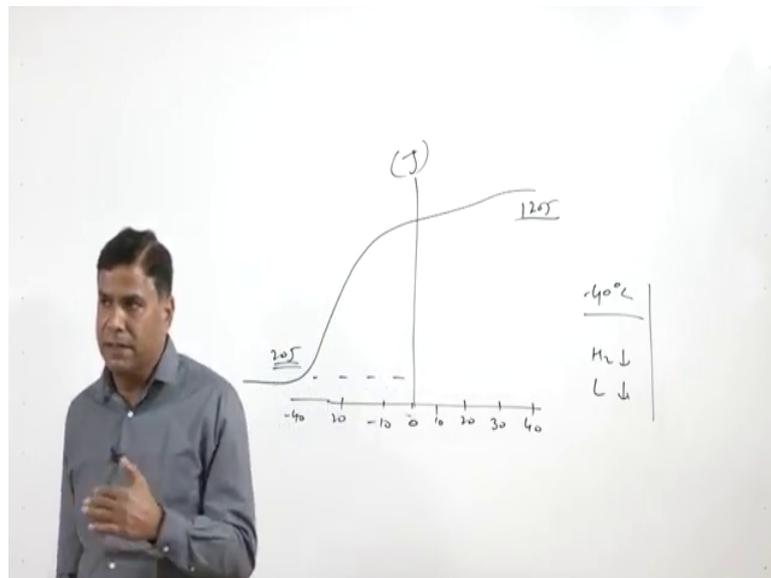
(Refer Slide Time: 19:20)

In that case we have to conduct one additional study, which we can say the study under the simulated temperature conditions and for that we need to study that the brittle transition behavior of the rail steel.

And for that like say we will be testing the rail under the different temperature conditions 20, 10 minus 10, here 0 minus 10, 20, 40 like this. So, we can have it here for 0 and here the toughness in terms of the energy observed and rail steel if shows that there is a very sharp drop in the toughness at minus 40 degree centigrade. So, the steel which was having like say 120 joule of the impact toughness and it was reduced to only the 20 joule. So, this such a sharp drop in the toughness is indicating that rail had very low toughness under those conditions and because of that only the failure has taken place under the sudden load conditions.

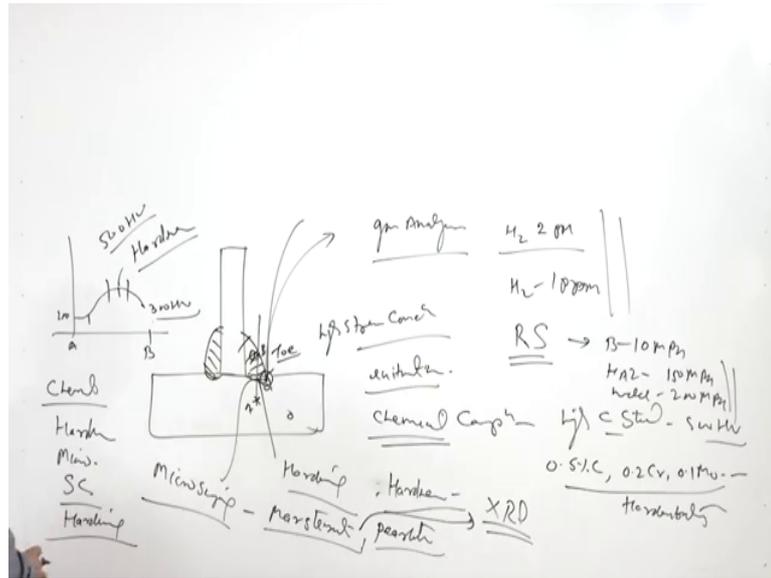
(Refer Slide Time: 21:57)

So, this is the obviously, the fracture initiation sight due to the high stress the fracture initiation sight due to the high stress concentration by, but why it has take place for establishing that we need to study all aspects like because, from the macroscopy we can easily say that this is the region of the high stress concentration.

But to why it has not tolerated the crack nucleation to establish that we have to carry out the extensive study on the various aspects, which we include like chemical composition if it is coming out to be of the high carbon steel; leading to the high hardness of the 500 HV. And then chemical composition may have like say 0.5 percent carbon, 0.2 percent chromium, 0.1 percent molybdenum and other residual elements. So, all these will be increasing the harden ability of the steel. And this then thereafter we can do the hardness study hardness study of the weld area where failure has taken place.

So, we can measure the hardness across the weld which is starting from the weld to the base metal and what we will be finding in this case especially, if we measure from A to the B location and then the hardness is plotted A to B. So, as soon as hardness is low, but as soon as we reach to the heat affected zone and then in the weld we find that there is a drop in there is . So, this is the base this is the heat affected zone and this is the weld.

So, weld is softer, but heat affected zone is harder the base is softer. So, this is what is shown so heat affected zone is hardness of the heat affected zone is high in this case which say if it is coming out to be of the 500 HV and the base metal is of having say 200

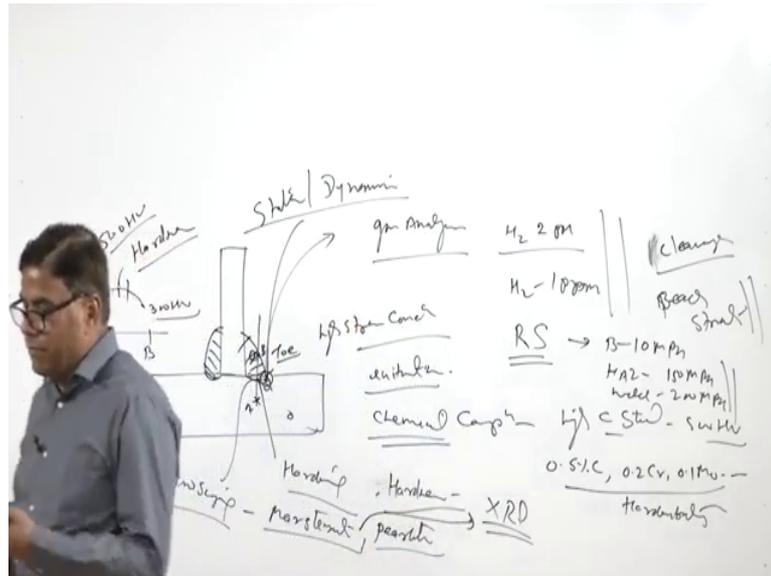
(Refer Slide Time: 28:03)

Now, whether it has been take this cracking has taken place under the static load condition or the dynamic load condition, that is what we can further establish through the macroscopy as well as the microscopy of the fracture surface. So, if it is a simply overload fracture then it will be indicating the cleavage facets on the fracture surface; the brittle brack the flat sign in fracture surface why and the macroscopy will be showing the cleavage facets, but if it is and if the failure has taken place under the cyclic load conditions; then it will be showing the beach marks striations on the fractures the fracture surface.

So, depending upon the kind of the features which are present on the fracture surface; we can suggest that if the fracture has taken and the cracking has taken place under the static load conditions or under the cyclic load conditions. Now here I will summarize this presentation in this presentation, I have talked about some general examples for and the way by which the failure analysis can be taken up to identify the potential causes of the failure.
